APPENDIX D

Appendix D-1
Photographs of Hills South Parcel/Kracke Property

**PHOTOGRAPHS OF IMPACTED AREAS
HILLS SOUTH PARCEL/KRACKE PROPERTY**

**The Hills
at
Southampton**

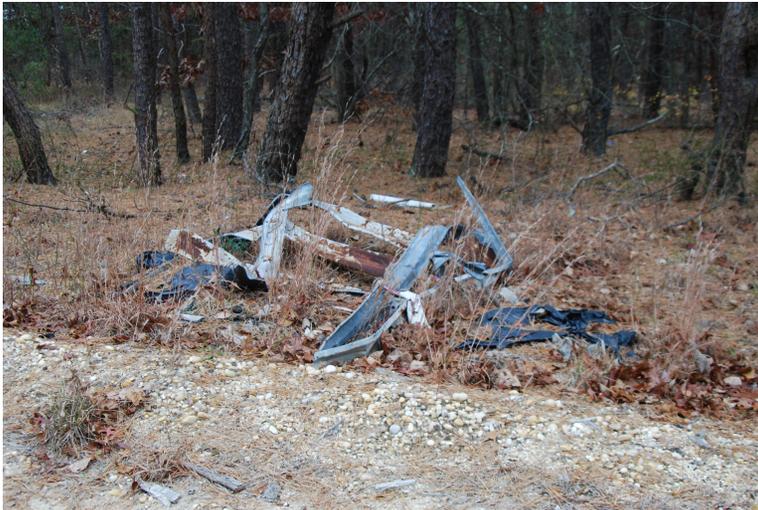
1. View of scrap metal in center portion of subject property

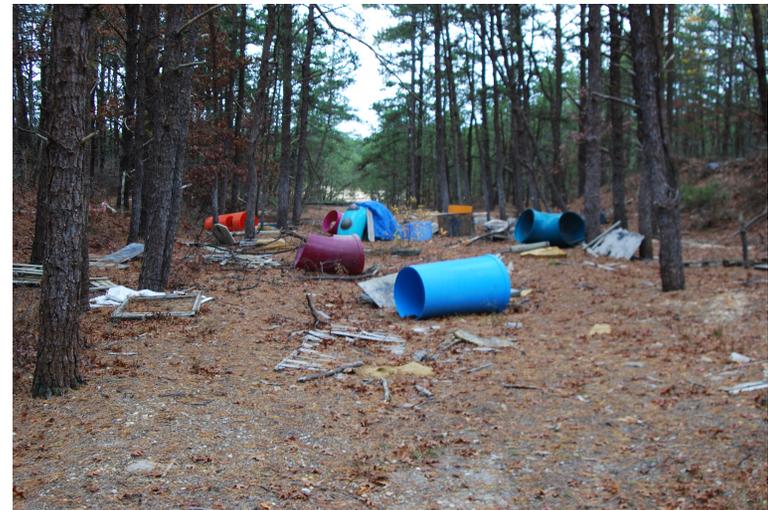
2. View of playset and debris in center portion of subject property

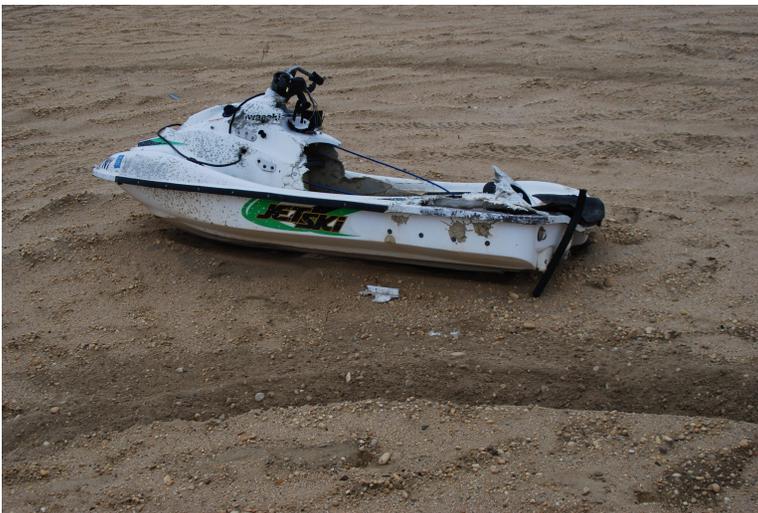
3-1. View of jetski in center portion of subject property

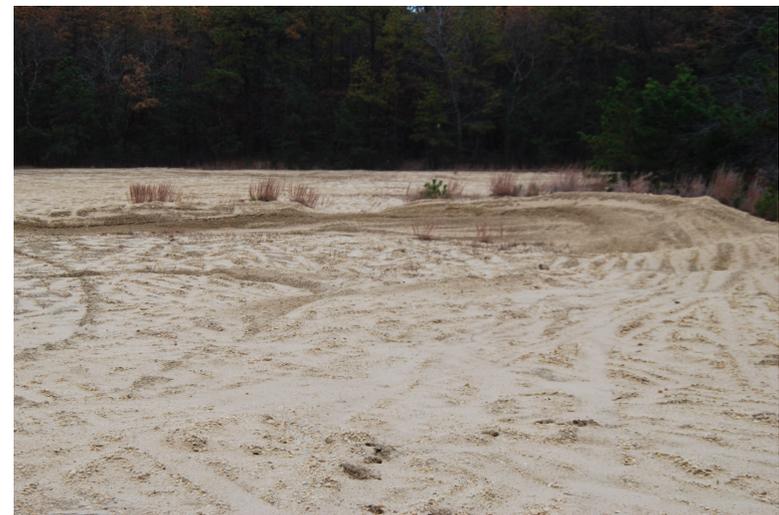
3-2. View of ATV tracks in center portion of subject property

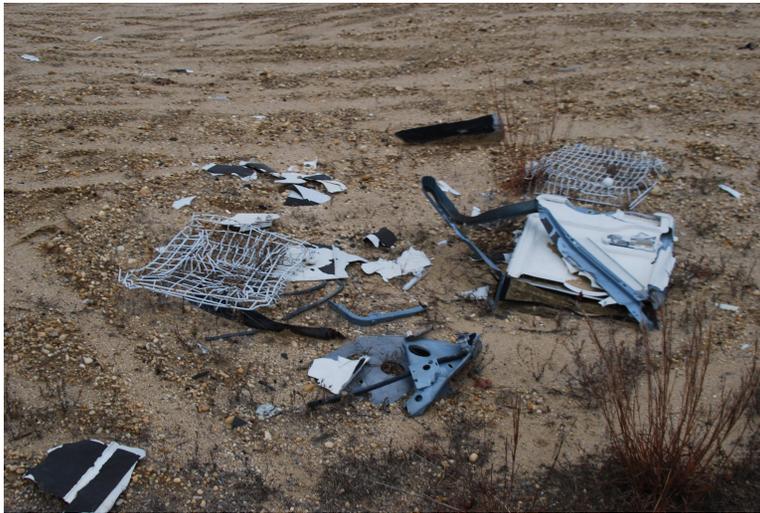
3-3.View of debris in center portion of subject property

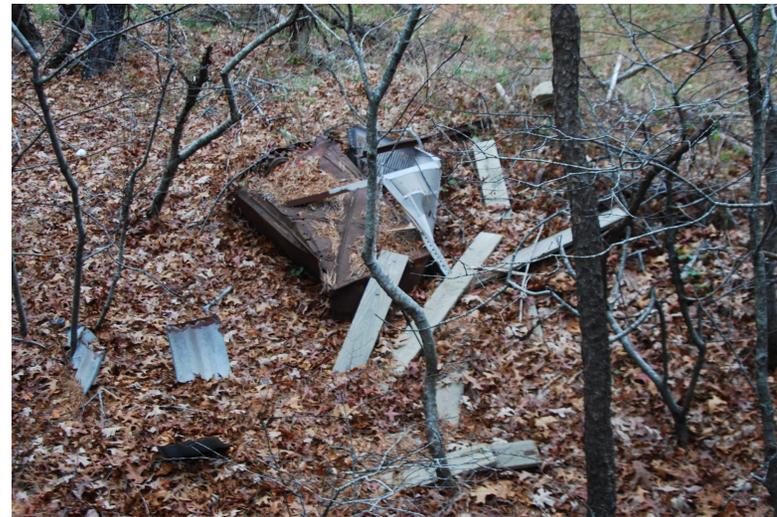
4.View of debris in center east portion of subject property

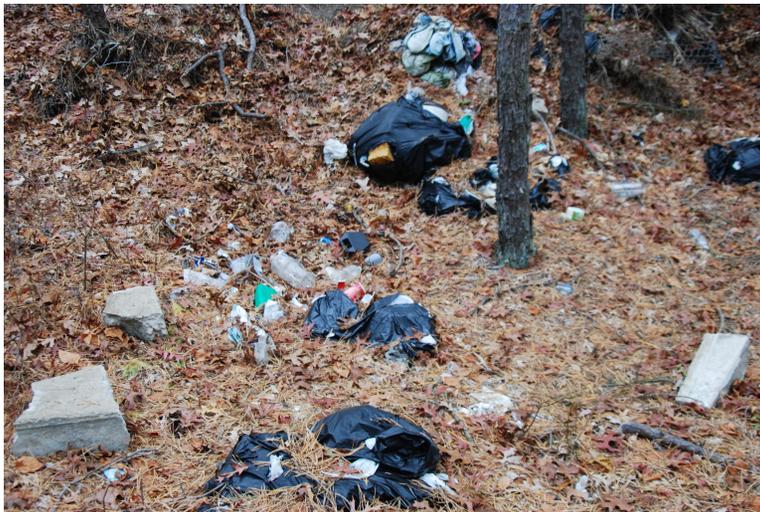
5.View of garbage bags and debris in center portion of subject property

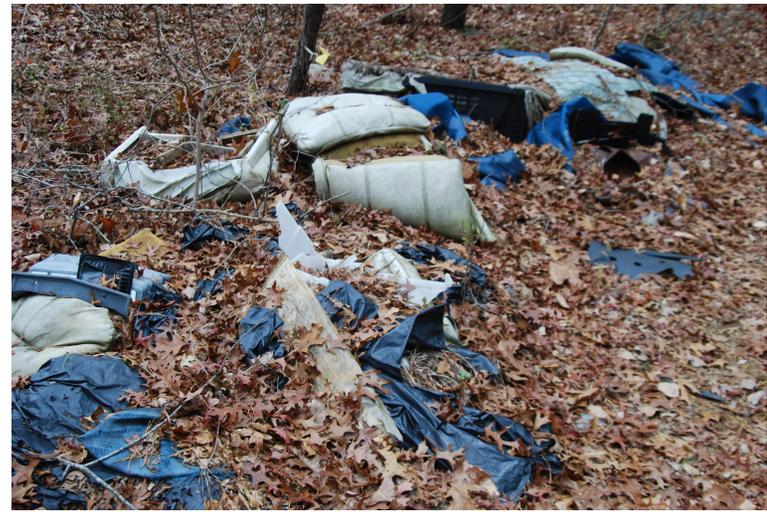
6.View of garbage bags and debris in center portion of subject property

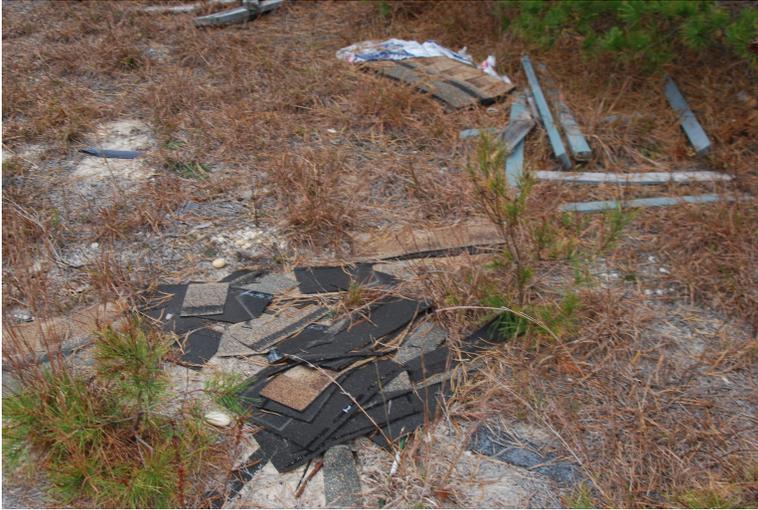
7-1. View of shingles and construction debris in center north portion of subject property

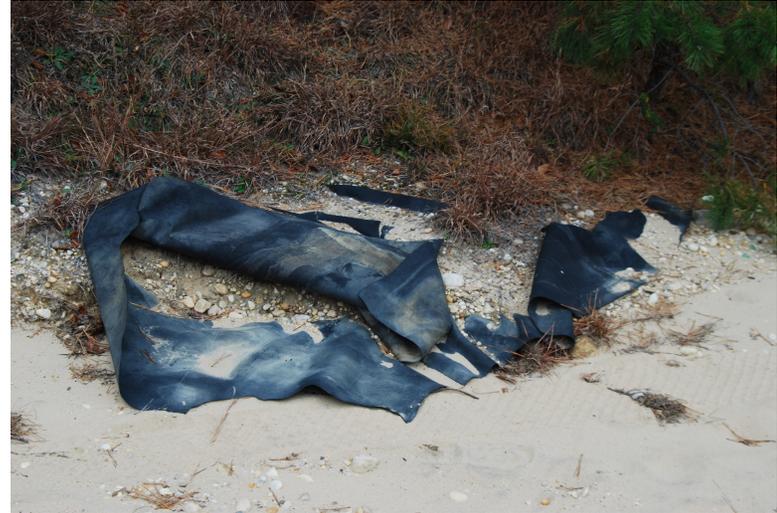
7-2. View of rubber construction debris in center portion of subject property

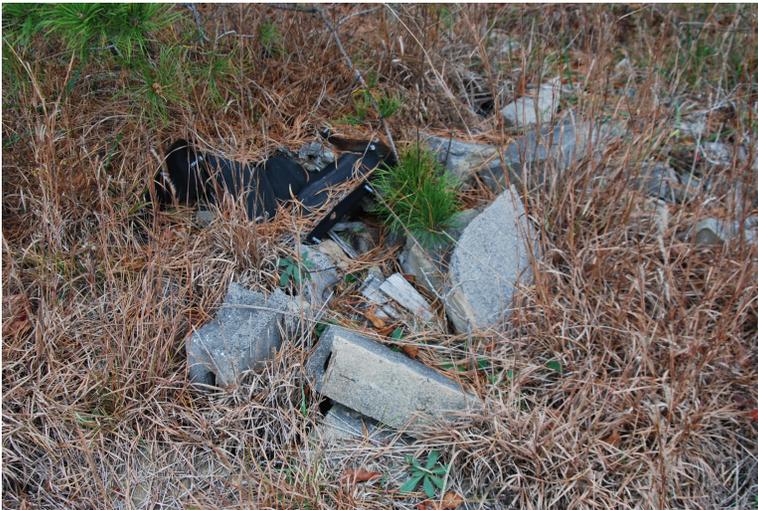
7-3. View of concrete and construction debris in center north portion of subject property

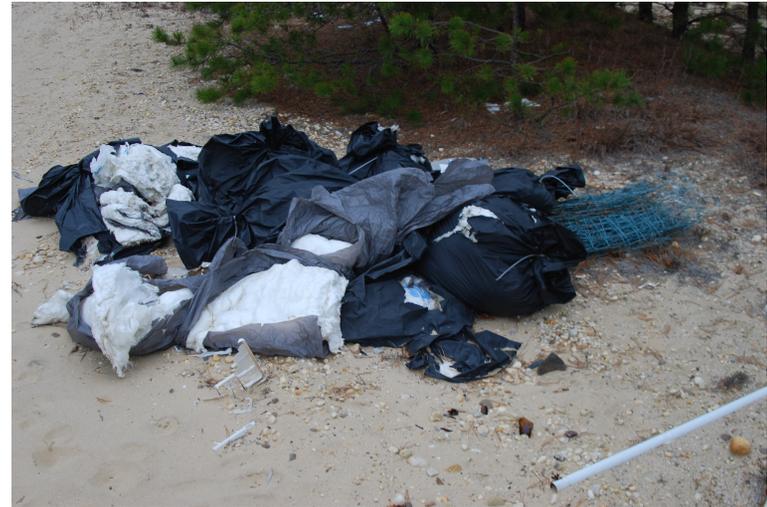
7-4. View of insulation and construction debris in center north portion of subject property

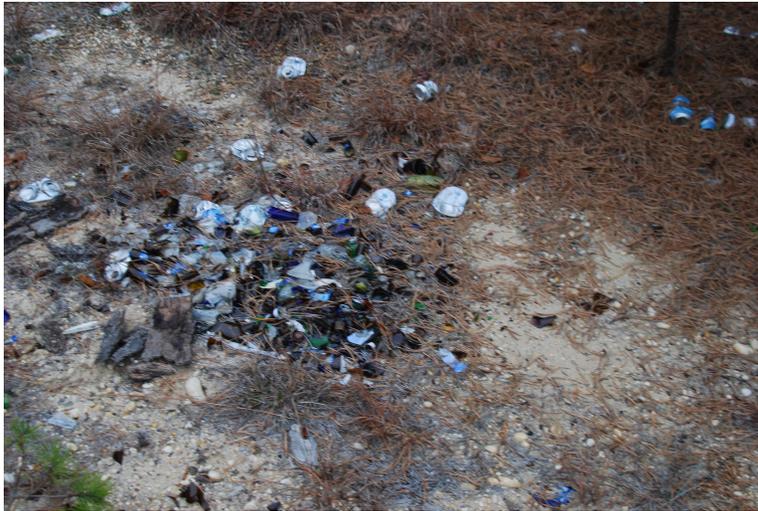
7-5. View of glass and plastic debris in center north portion of subject property

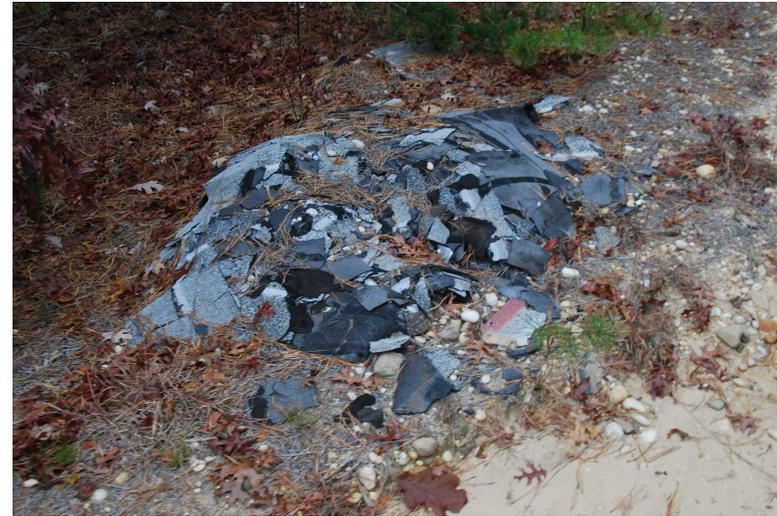
8-1. View of shingles in center north portion of subject property

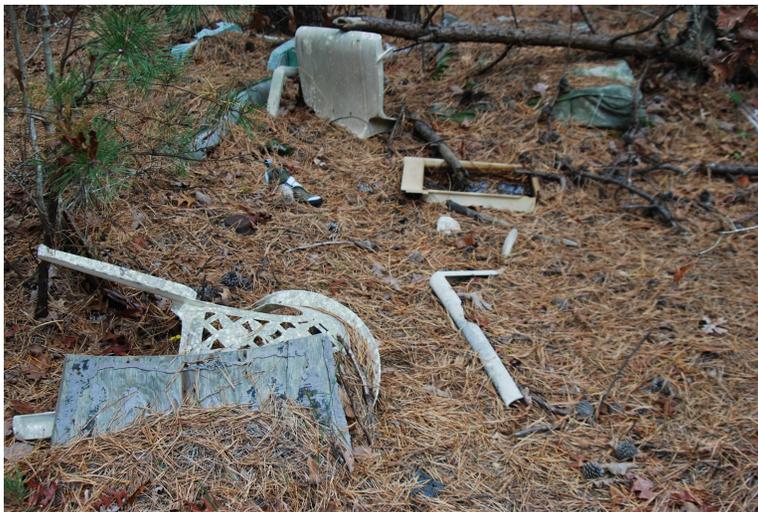
8-2. View of miscellaneous plastic and wood debris in center north portion of subject property

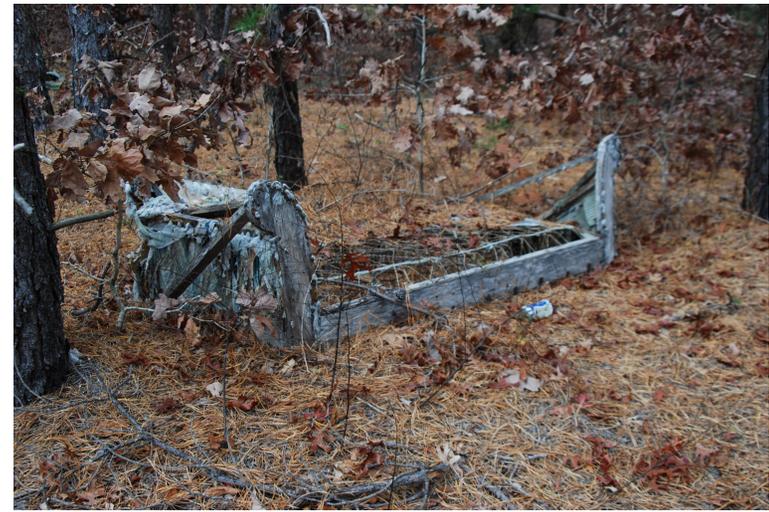
9-1. View of furniture in northeast portion of subject property

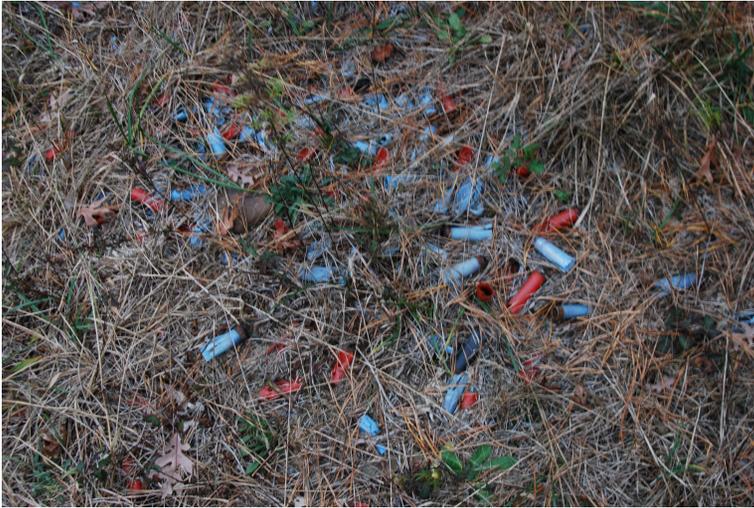
9-2. View of large pile of shotgun shells in northeast portion of subject property

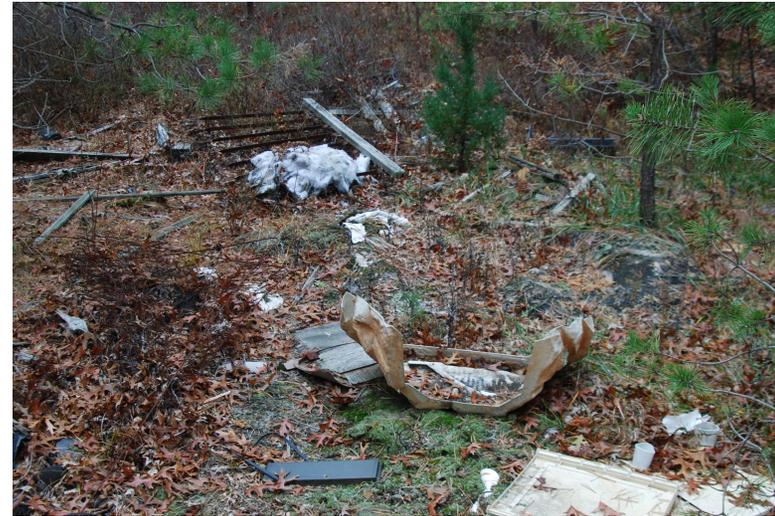
9-3. View of miscellaneous debris in northeast portion of subject property

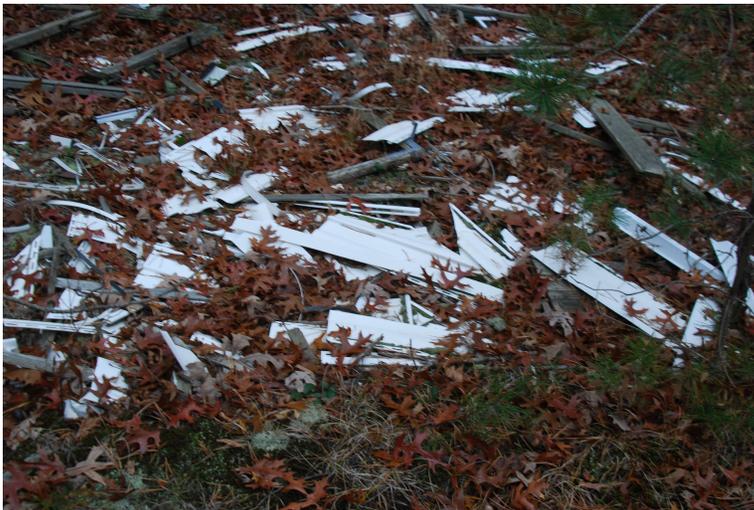
10-1. View of aluminum siding in northeast portion of subject property

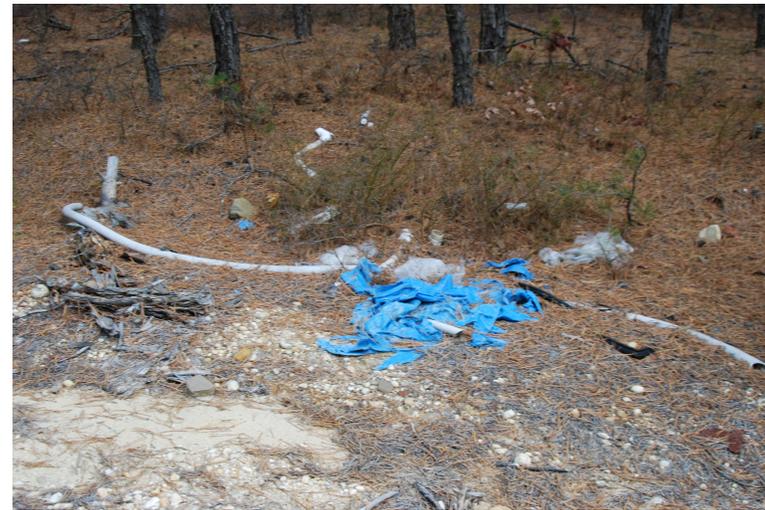
10-2. View of miscellaneous debris in northeast portion of subject property

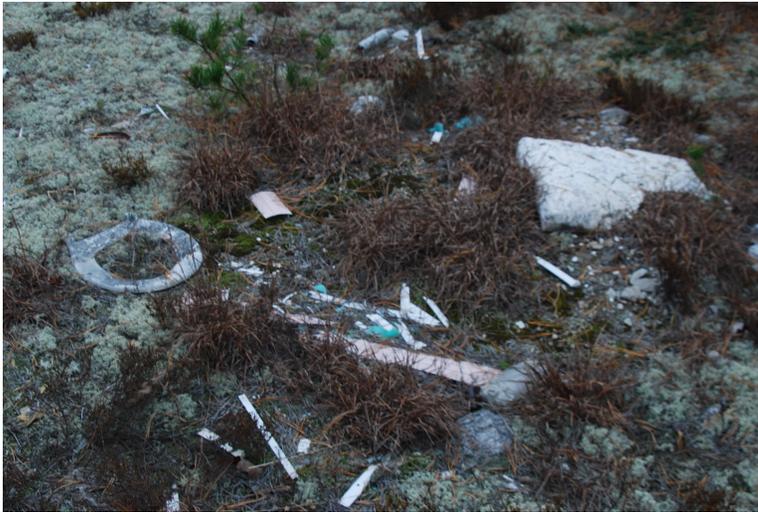
11. View of debris in north center portion of subject property

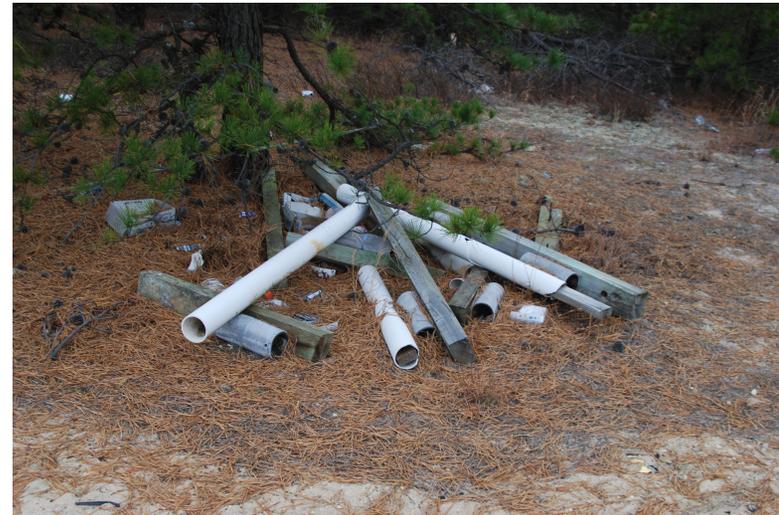
12. View of pvc pipe and construction debris in north center portion of subject property

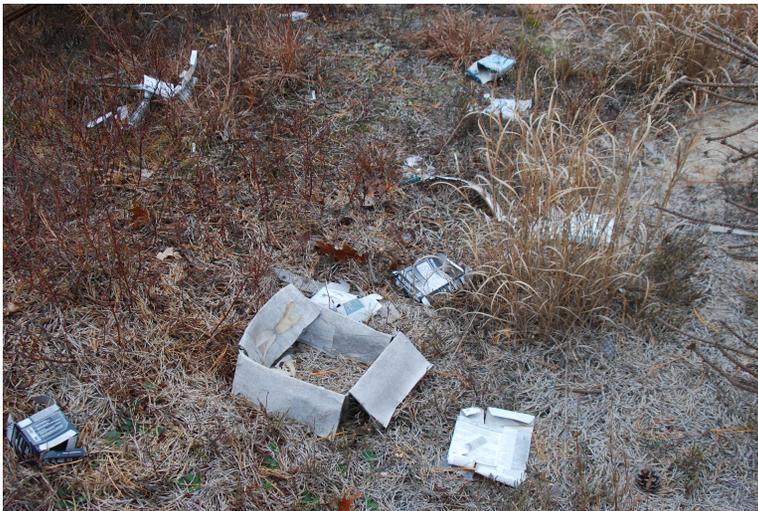
13. View of shotgun shells and clay pigeons in north center portion of subject property

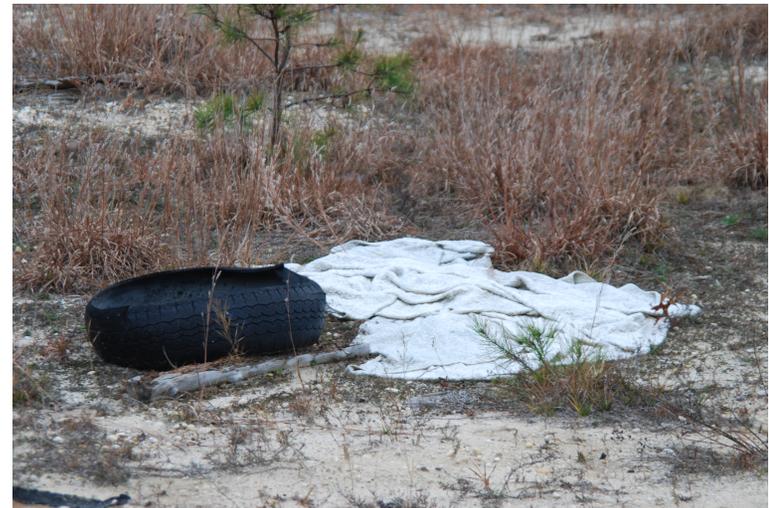
14. View of tire and debris in center west portion of subject property

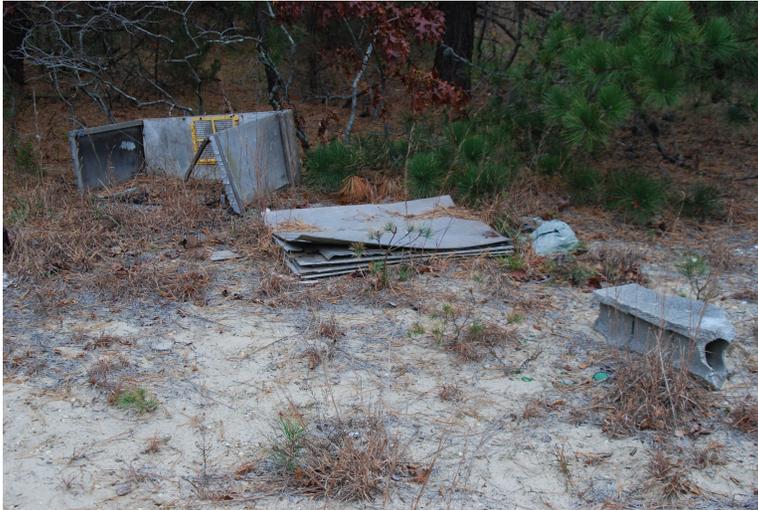
15. View of construction debris in center west portion of subject property

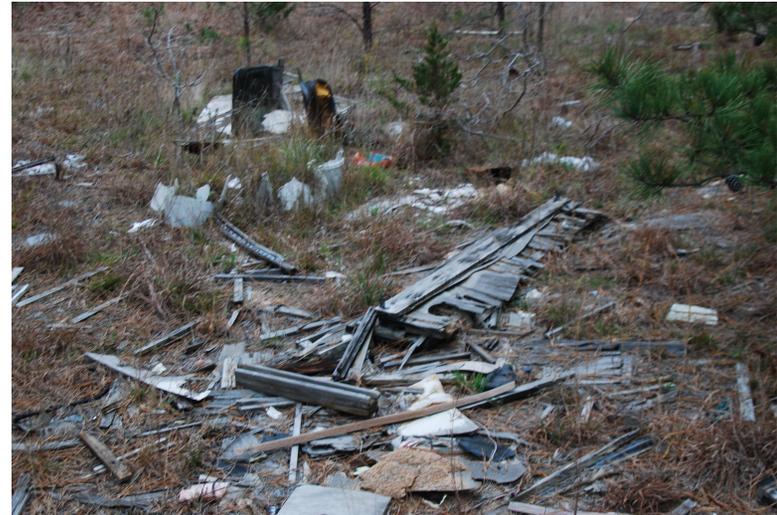
16. View of miscellaneous debris in center west portion of subject property

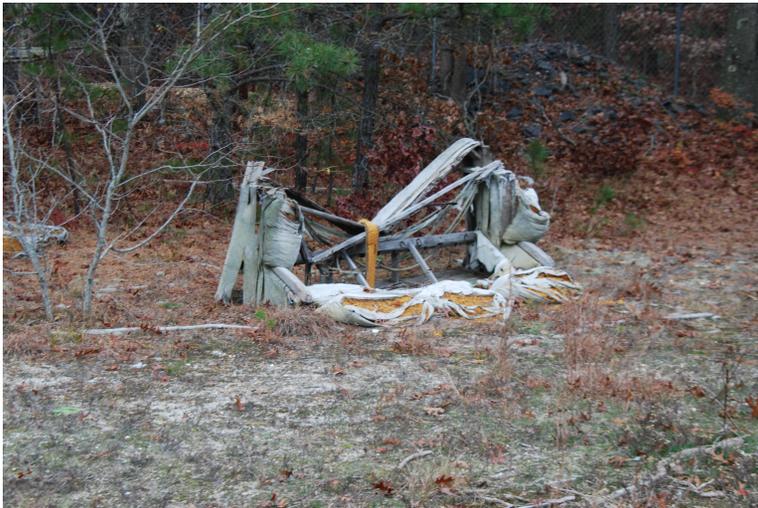
17. View of furniture in center portion of subject property

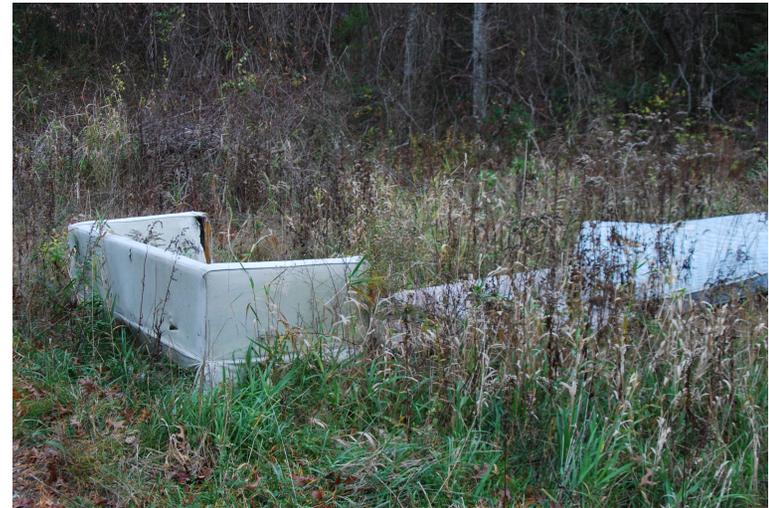
18. View of furniture in south portion of subject property

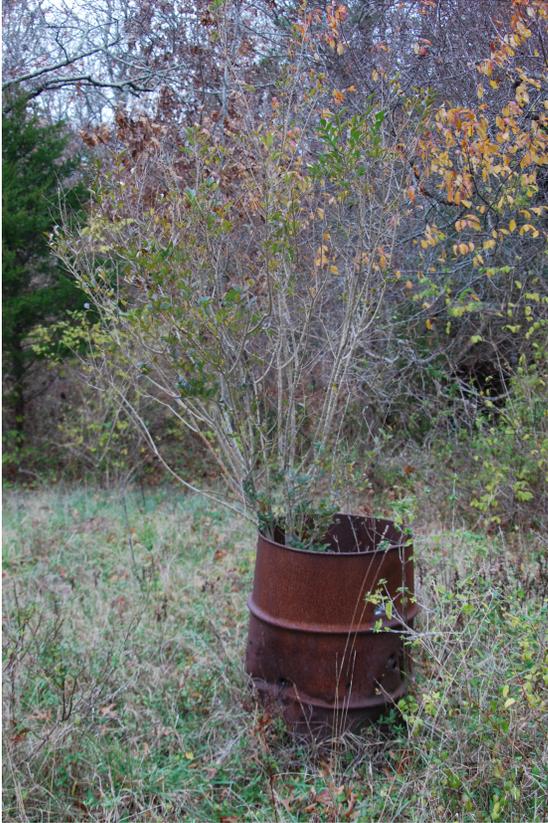
19. View of 55 gallon drum in south portion of subject property

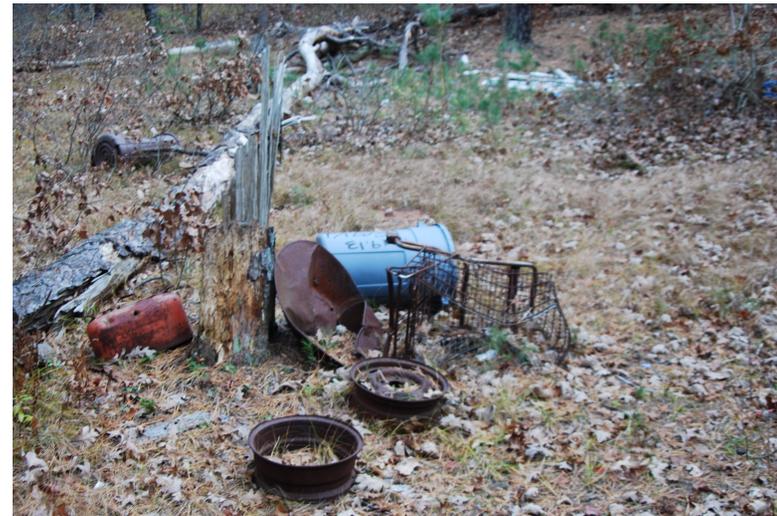
20. View of miscellaneous metal debris in south portion of subject property

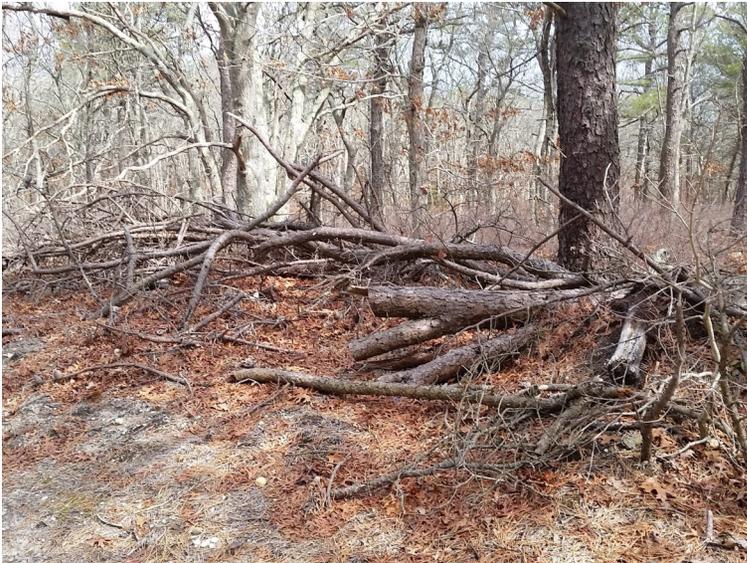
1. View of debris pile in southern portion of the property.

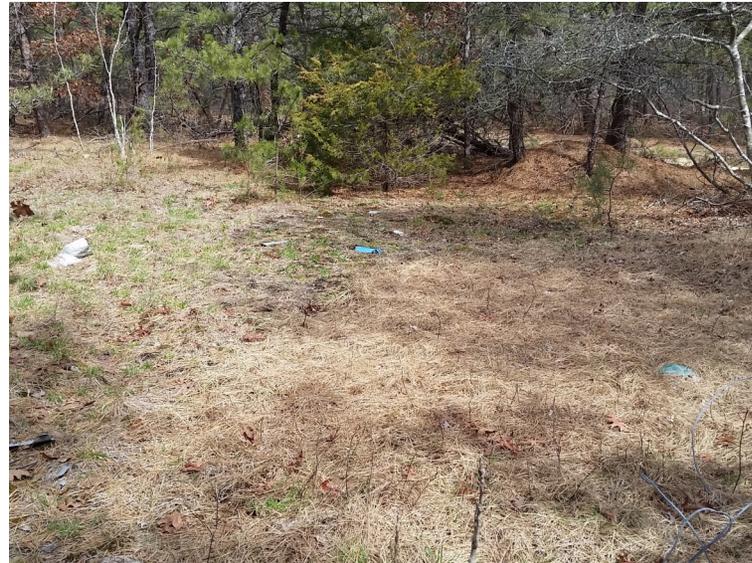
2. View of debris pile in southern portion of the property.

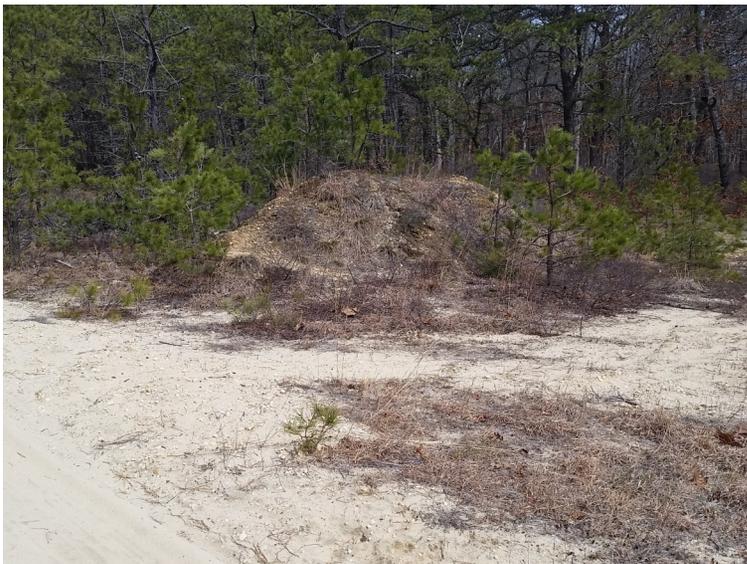
3. View soil and sand pile along the dirt trail.

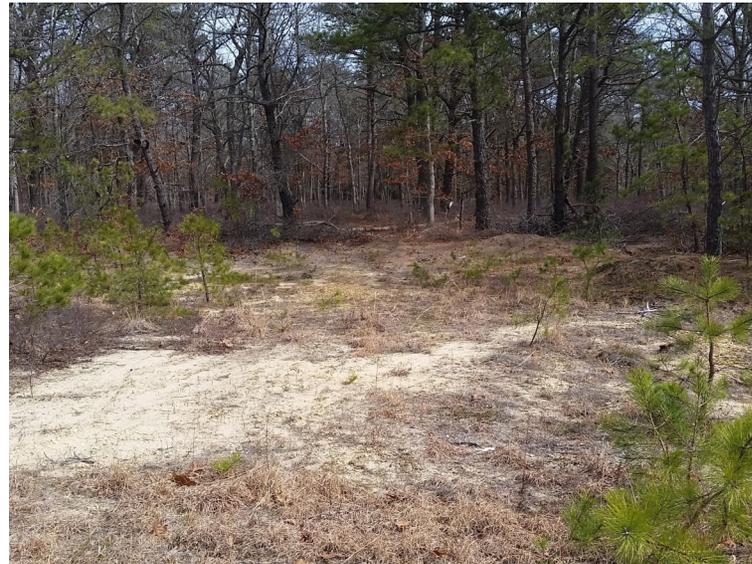
4. View cleared area and debris pile next to dirt trail.

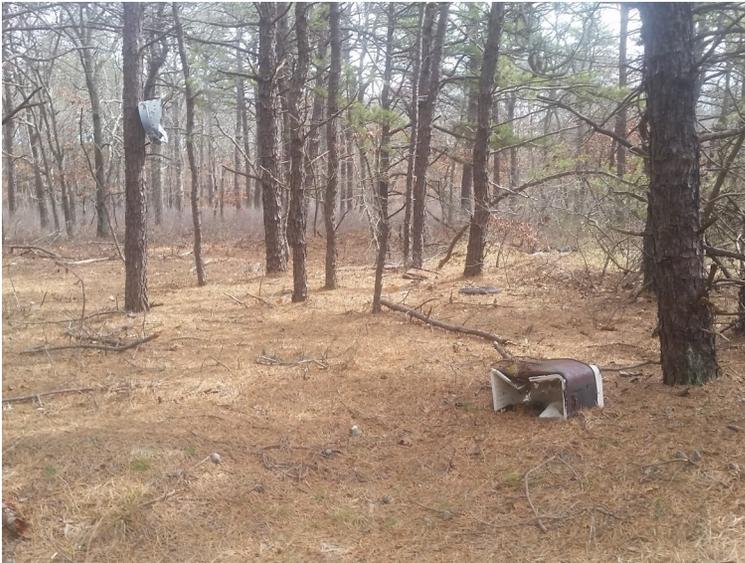
5. View of debris on the east side of the dirt trail in the central portion of the property.

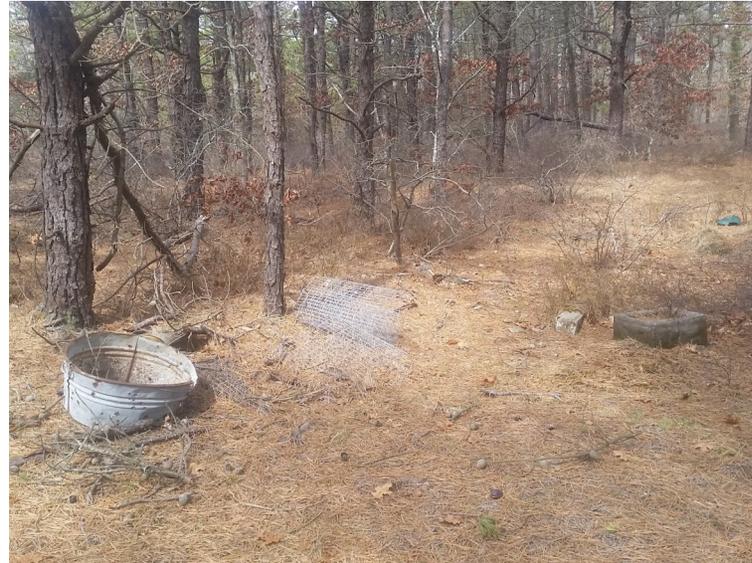
6. View of debris on the east side of the dirt trail in the central portion of the property.

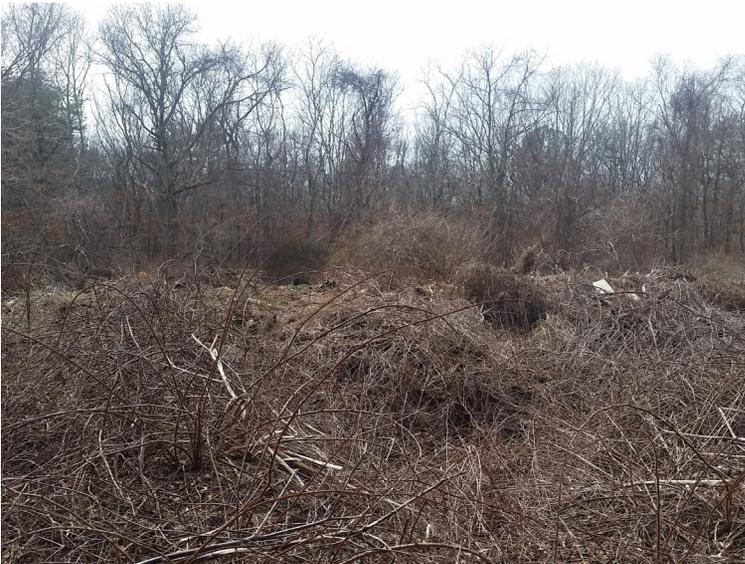
7. View of landscape debris in the northern portion of the property.

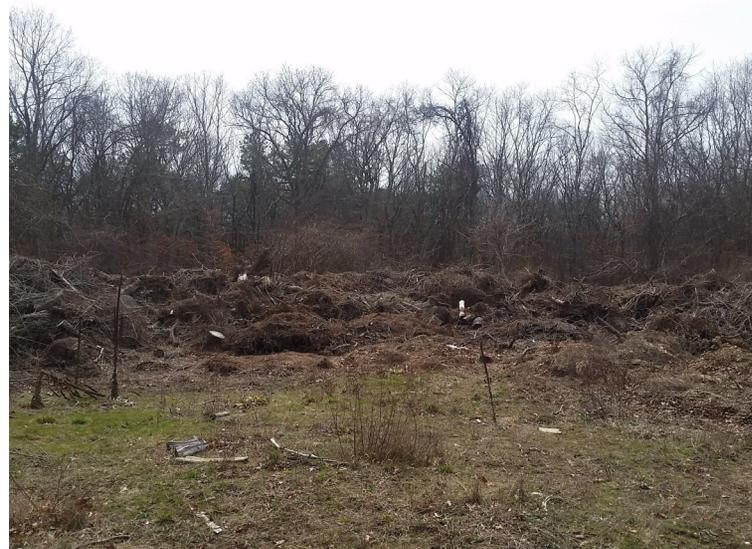
8. View looking south at landscape debris in the northern portion of the property.

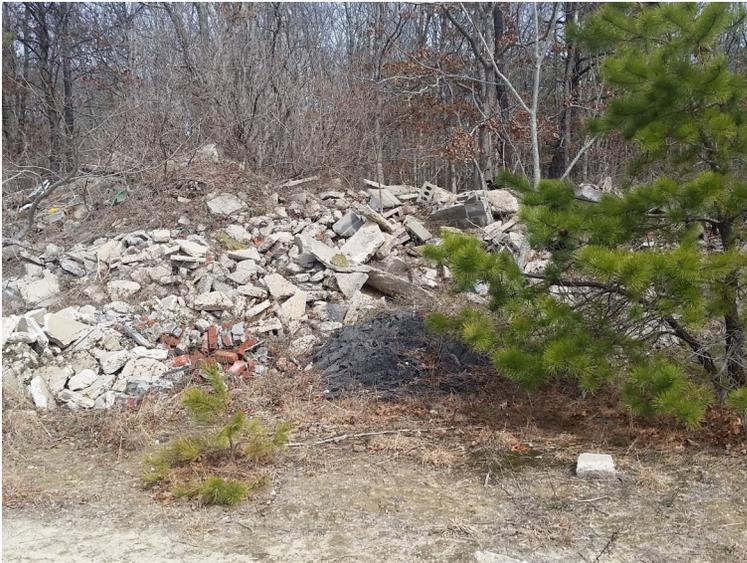
9. View looking north at construction debris in the northern portion of the property.

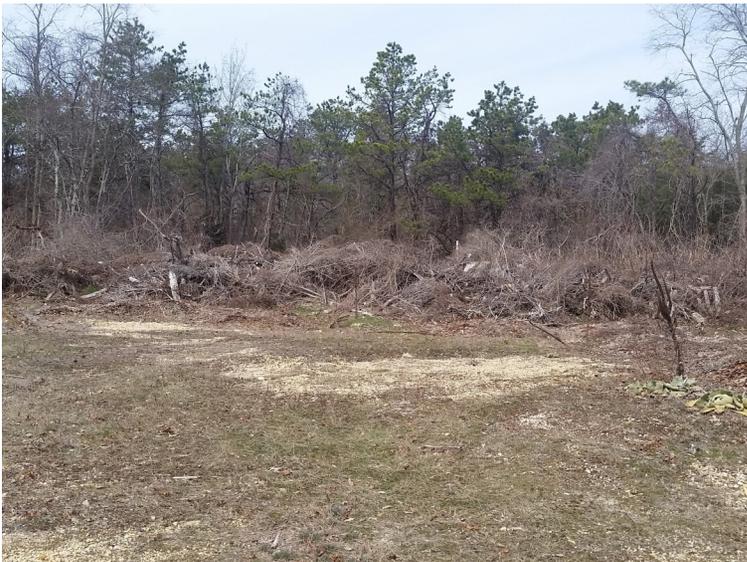
11. View looking north at landscape debris in the northern portion of the property.

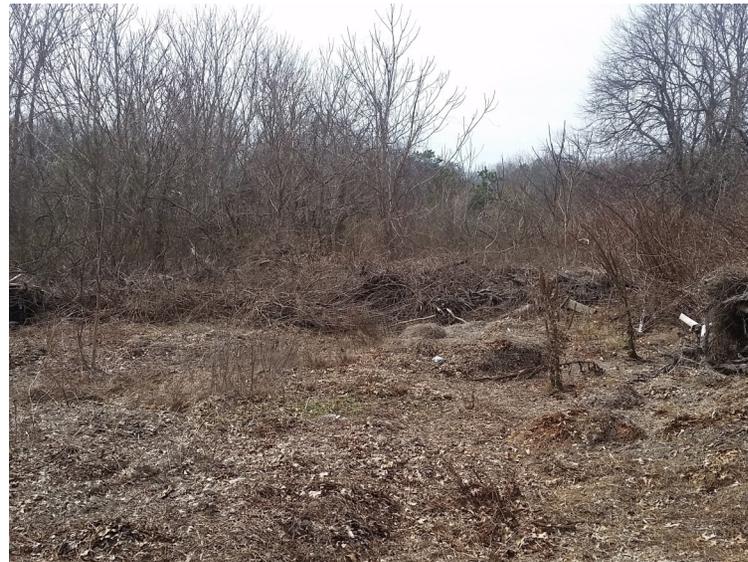
12. View looking west at landscape debris in the northern portion of the property.

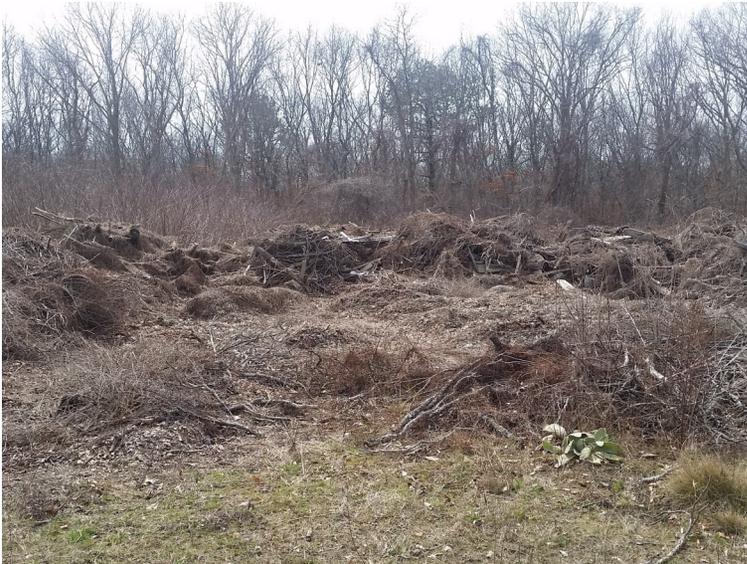
13. View of landscape debris in the central area of the northern portion of the property.

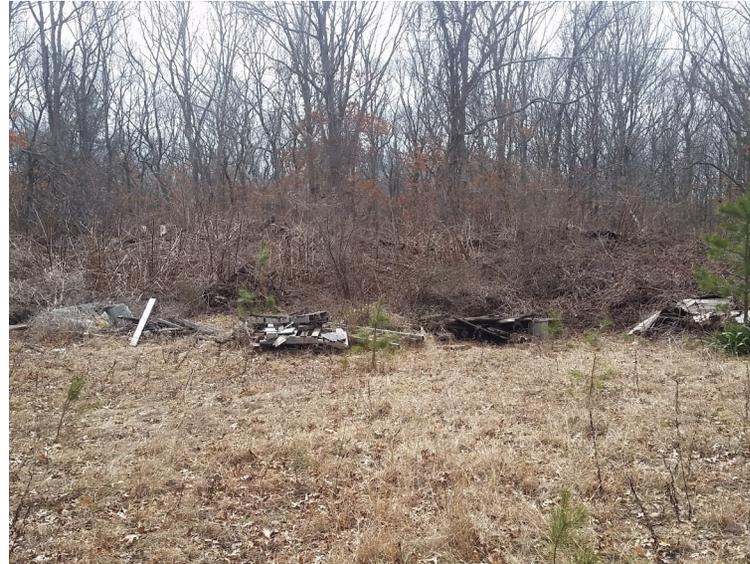
14. View of debris in the central area of northern portion of the property.

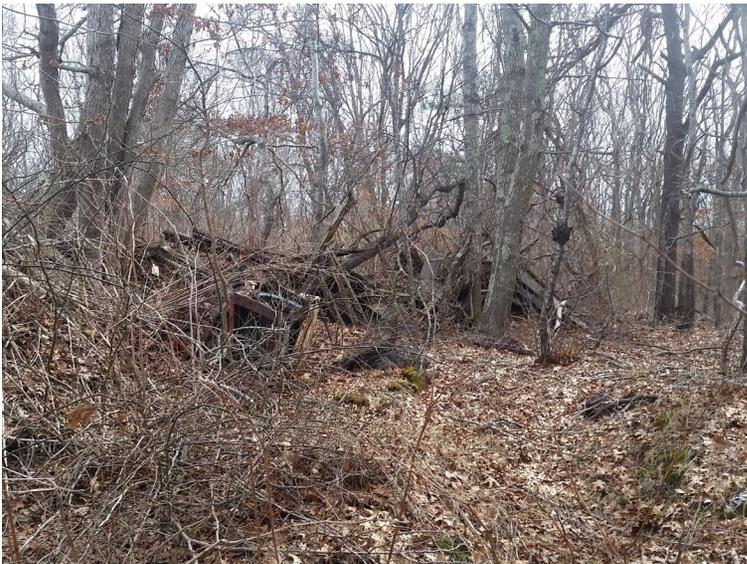
15. View landscape and construction debris in the central area of the northern portion of the property.

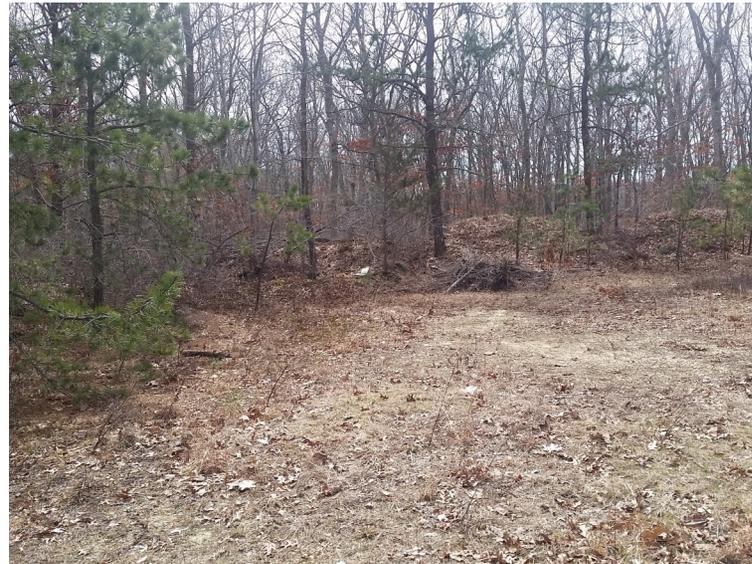
16. View of landscape debris in the central area of the northern portion of the property.

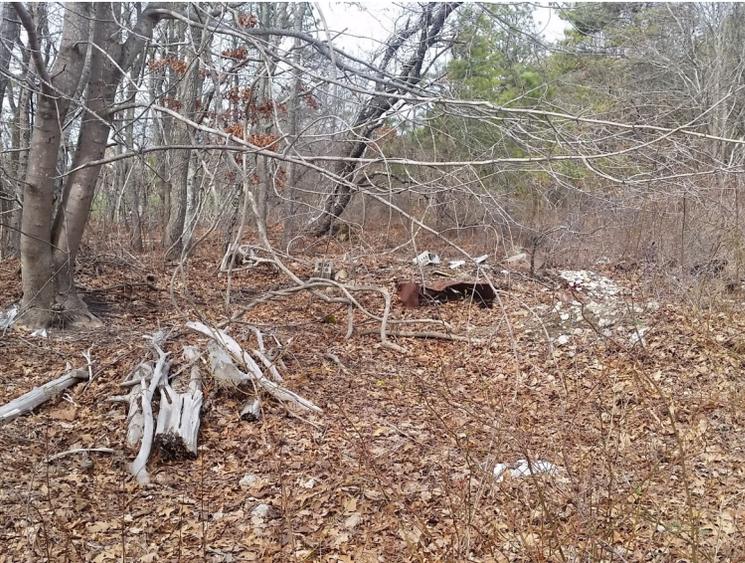
17. View of debris pile in northwestern portion of the property.

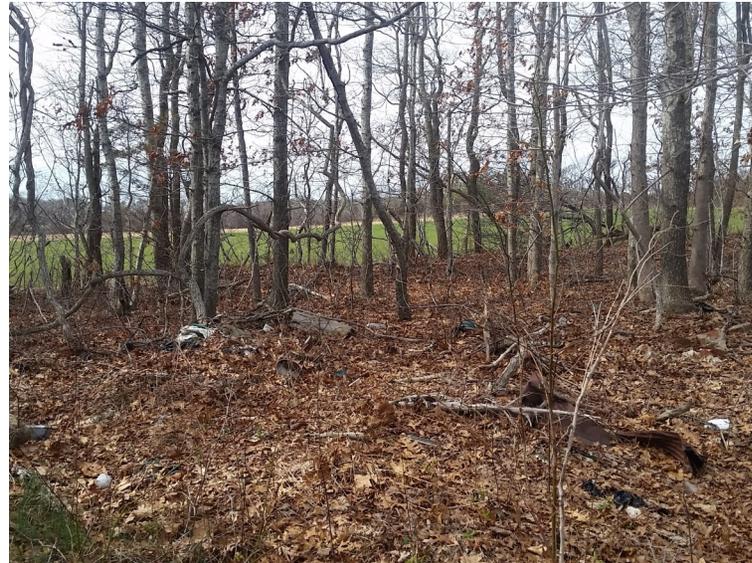
18. View of debris pile in northwestern portion of the property.

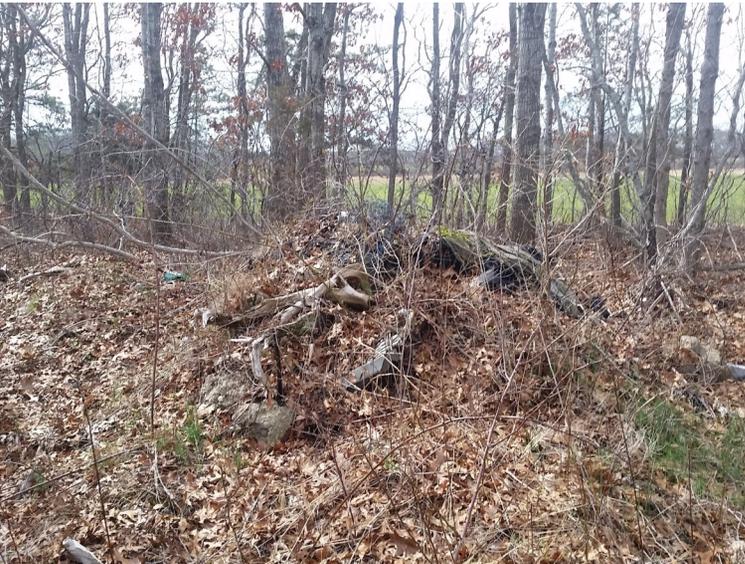
19. View of debris pile in northwestern portion of the property.

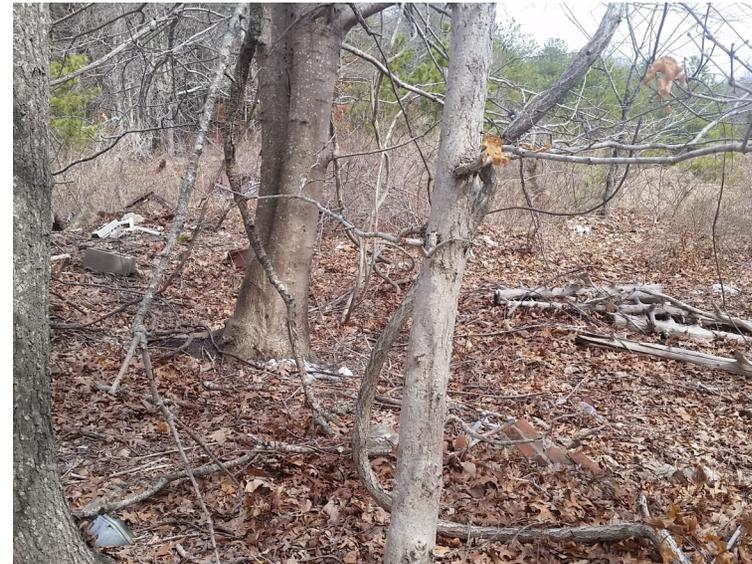
20. View of debris pile in northwestern portion of the property.

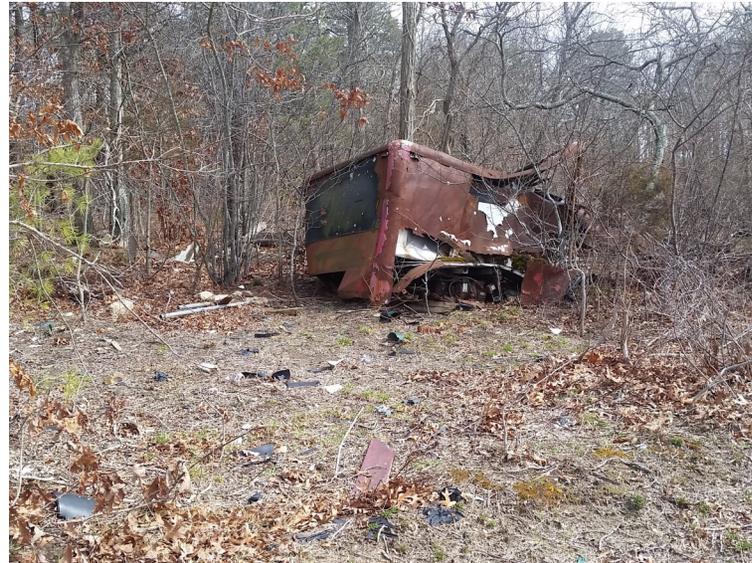
22. View of farming debris and dilapidated trailer in southern portion of subject property.

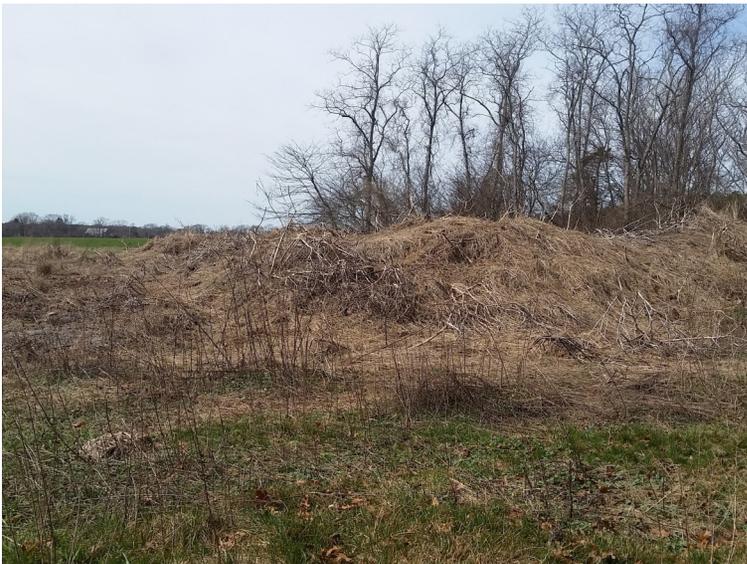
23. View native soil piles and natural debris in southern portion of subject property.

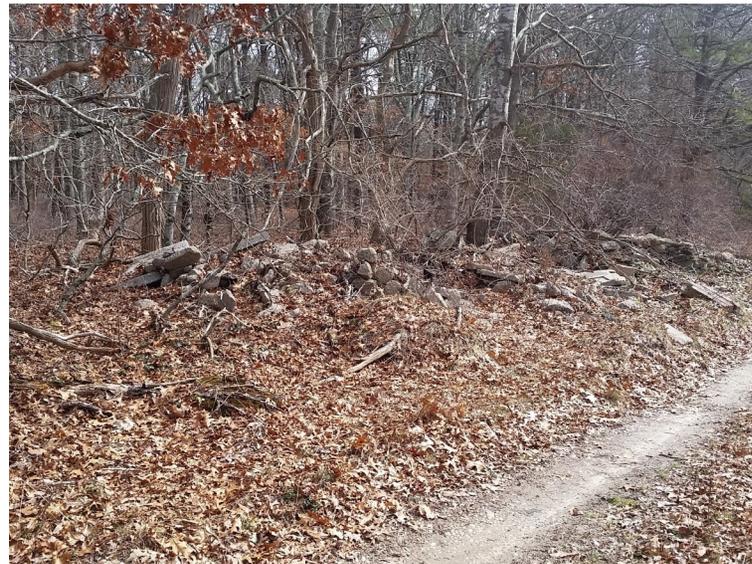
24. View of construction debris in the southeastern portion of the property.

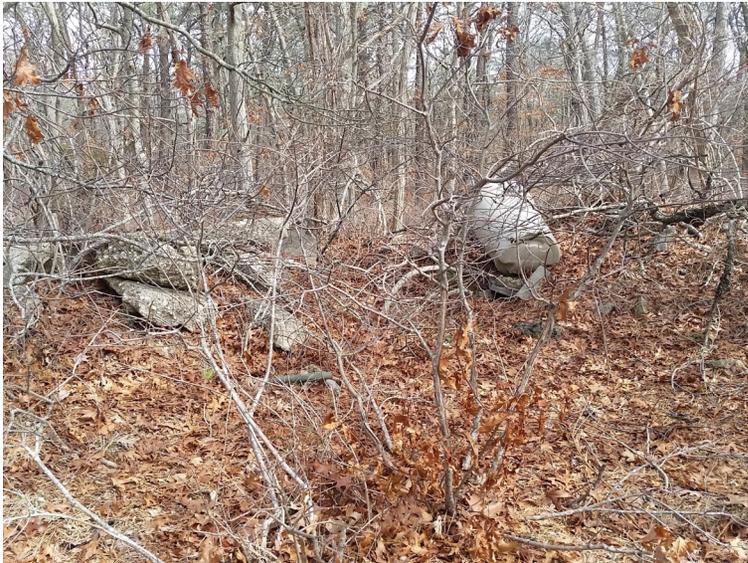
25. View of construction debris and litter in the southeastern portion of the property.

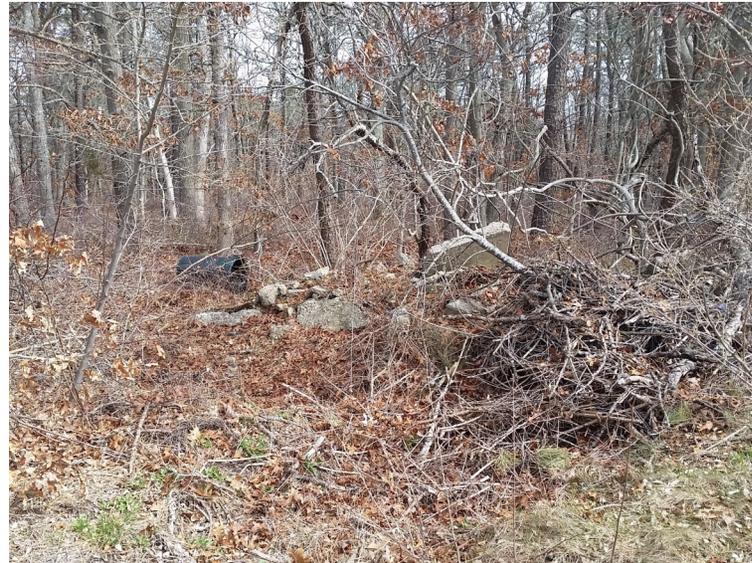
26. View of construction debris and litter in the southeastern portion of the property.
