APPENDIX D

Appendix D-1
Photographs of Hills South Parcel/Kracke Property

**PHOTOGRAPHS OF IMPACTED AREAS
HILLS SOUTH PARCEL/KRACKE PROPERTY**

**The Hills
at
Southampton**

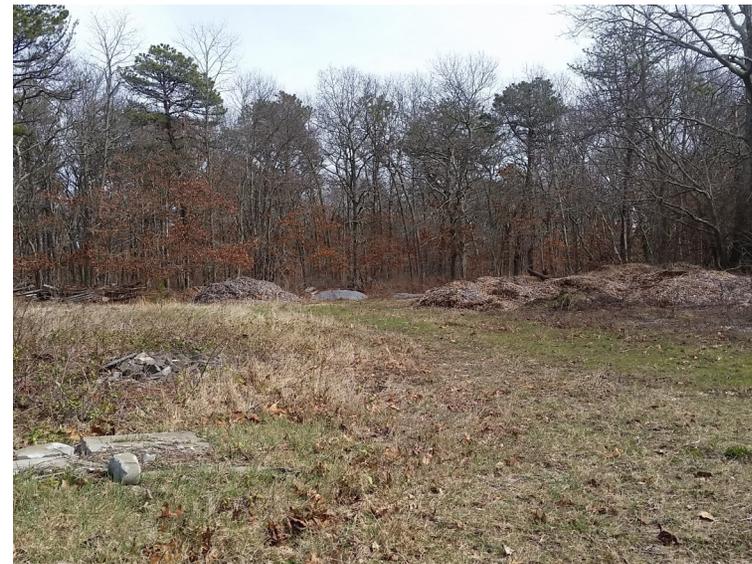
28. View cleared area and natural debris pile next to dirt trail in the southeastern portion of the property.
