**Limited Phase II  
Environmental Site Assessment**

**The Hills @ Southampton**

**East Quogue, New York**

**NP&V Job# 05105**

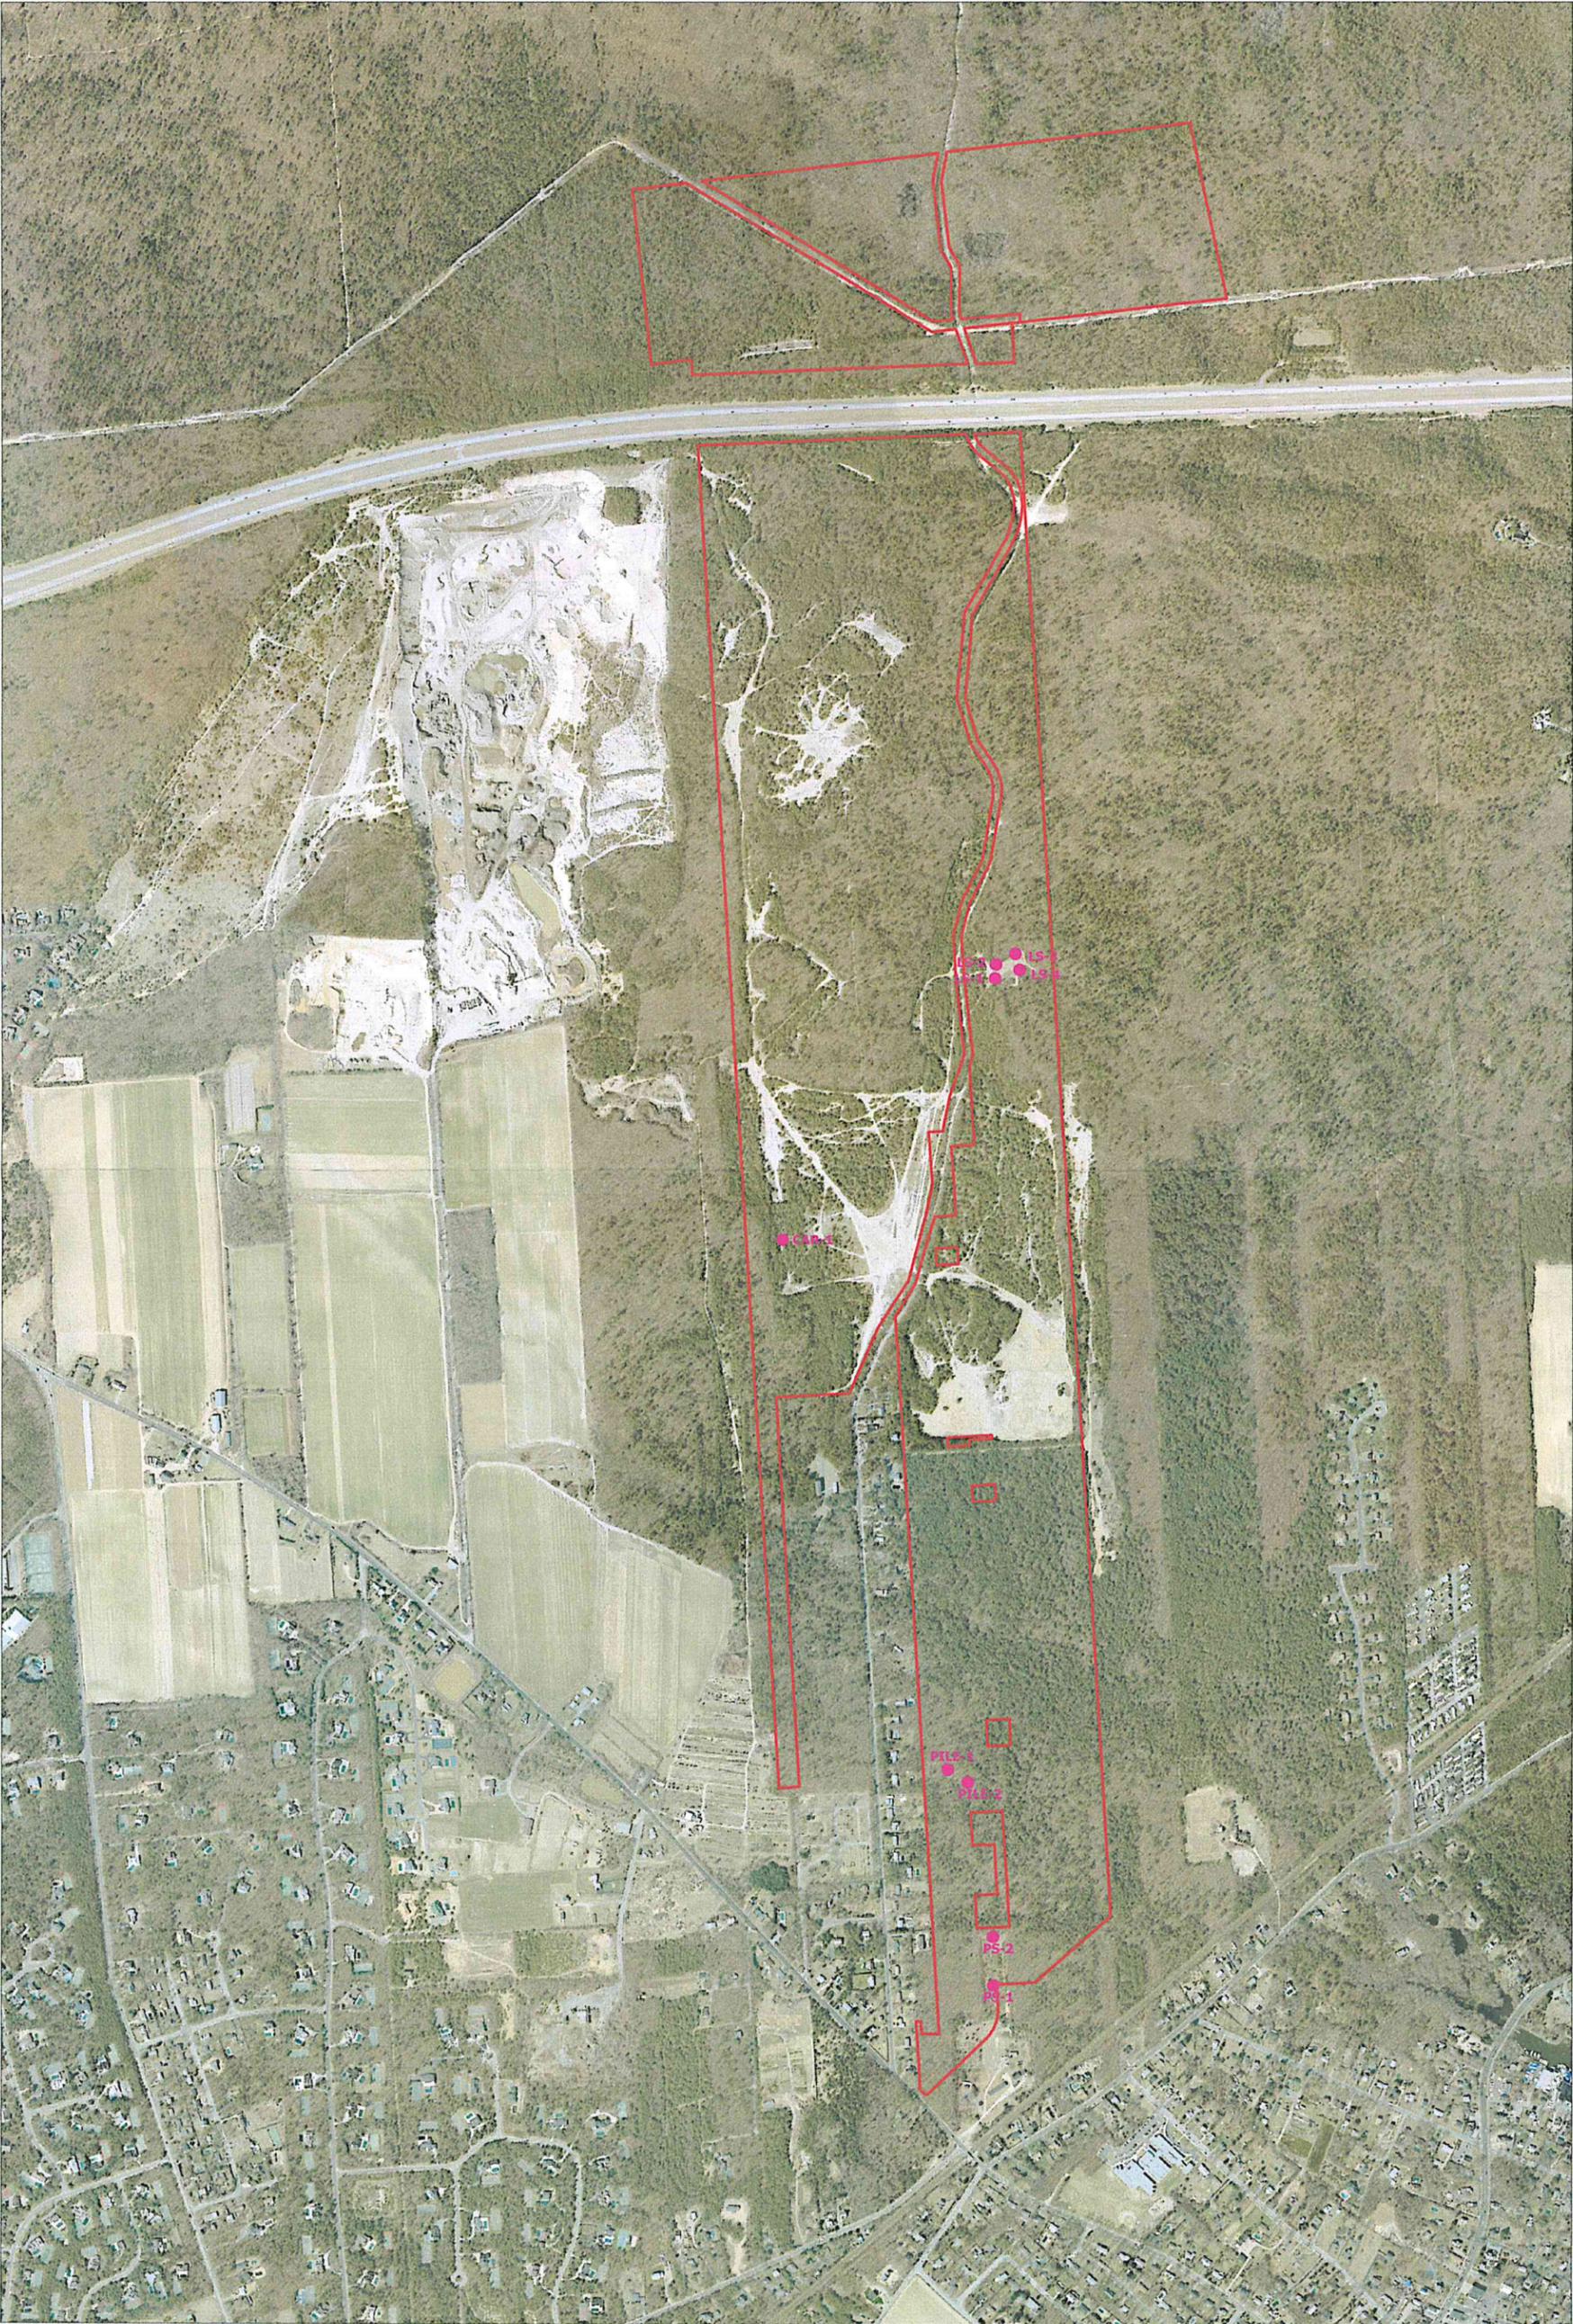
**FIGURE 1**  
**SAMPLE LOCATION MAP**

The soils in the vicinity of the shotgun shells and beneath the engine of the car located in the southwestern portion of the property were sampled using a stainless steel hand auger. The soil samples (LS-1 thru LS-4 and CAR-1) were collected from the upper six (6) inches of soil and were analyzed for the presence of lead, and volatile and semi-volatile organic compounds and metals, respectively. Soil samples (Pile-1 & Pile -2) were collected from numerous piles located on the east side of the houses situated along Spinney Road. **Figure 1** provides a location of the samples collected.
