Town of Southampton

Redevelopment of the Ponquogue Beach Bathing Facility

Public Workshop I

EXISTING FACILITY CONDITIONS

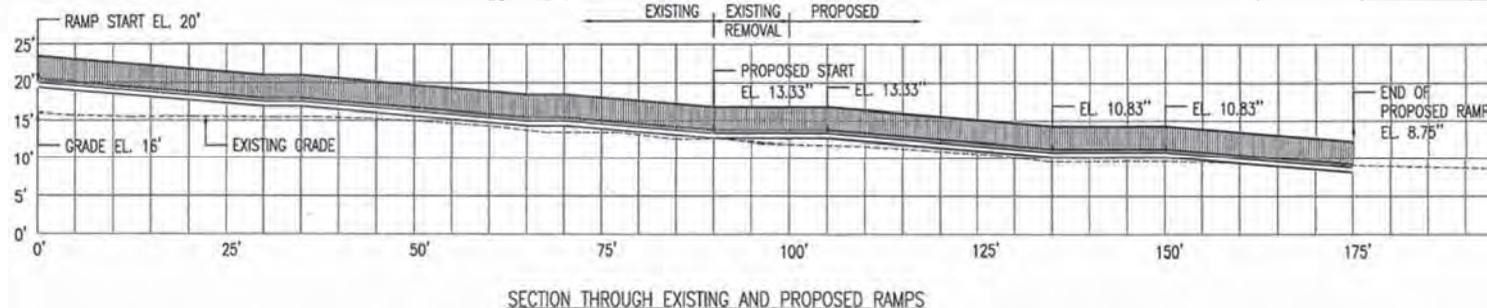
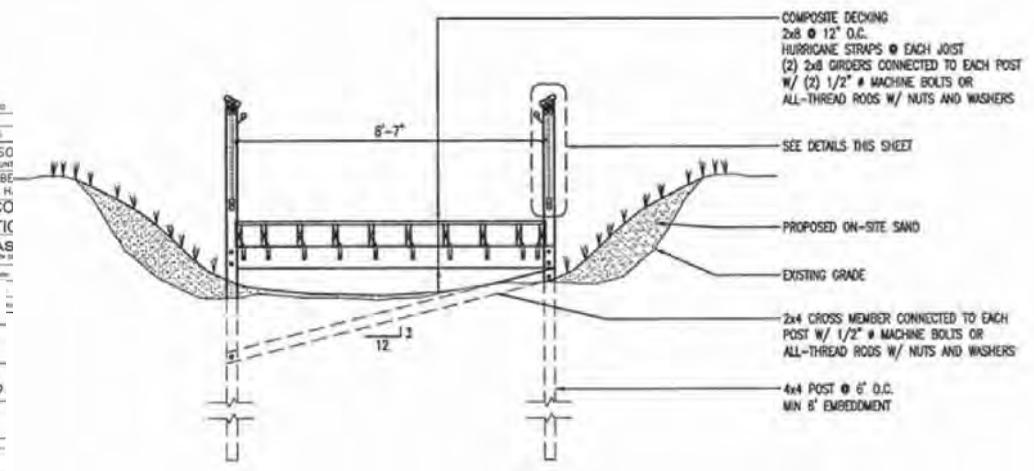
- ▶ Existing wood deck replacement with synthetic material
- ▶ Existing public access boardwalk replaced (approx. 100 ft)
- ▶ Additional 75 In. ft. of new boardwalk to the seaward end was constructed

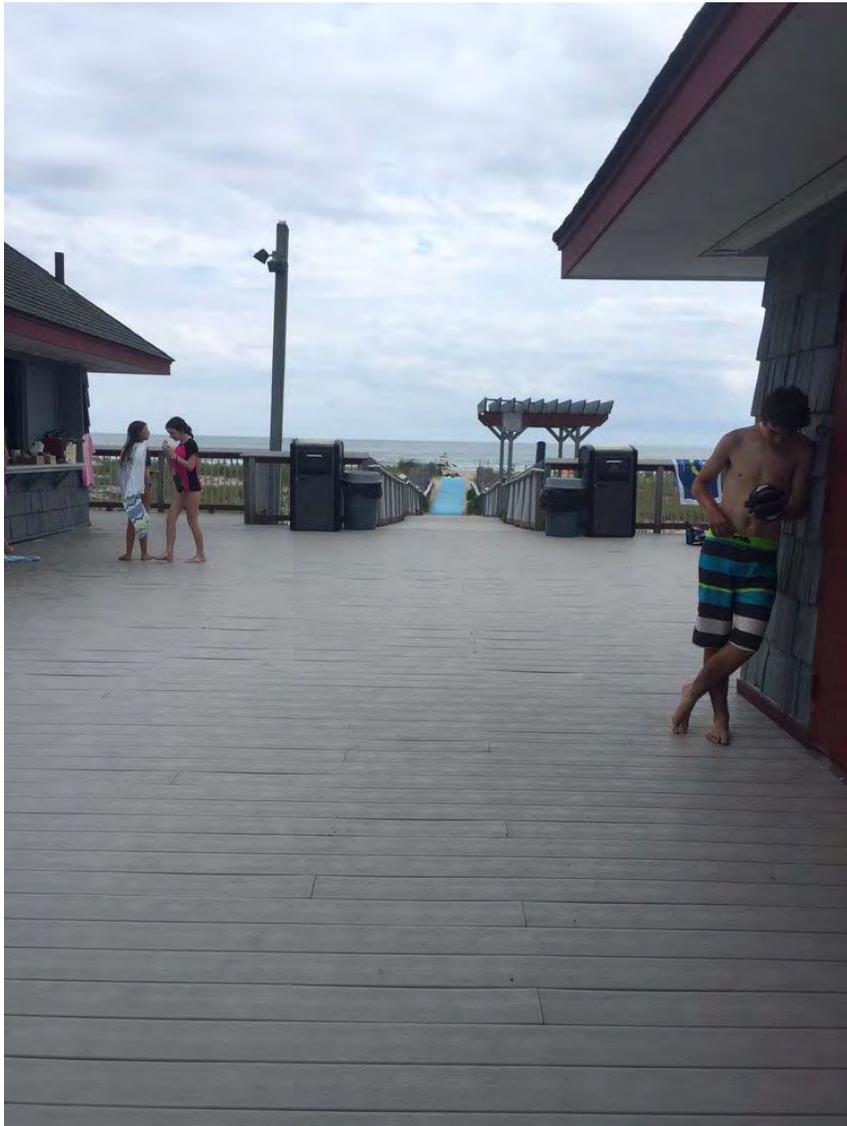
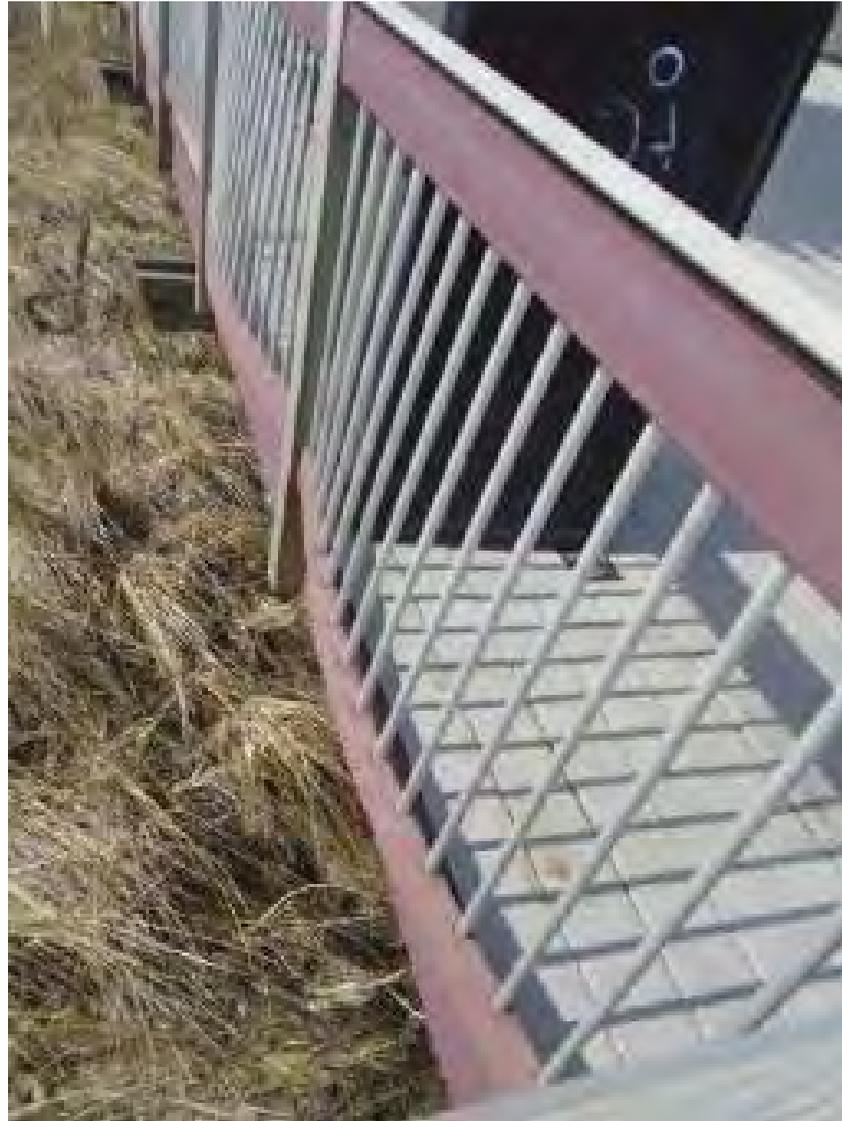
- ▶ Main Deck Structure - constructed in mid 1960's and substantially unchanged in configuration
- ▶ Piles -Treated Wood Piles – in good condition
- ▶ Pile Caps - overall are in good condition except lower pile caps on East side have termite damage – need replacement
- ▶ Stringers – rotting, termite damaged. Older stringers sistered with new. Termite infestation spreads from old members to new. Stringers were NOT replaced during 2009 renovation

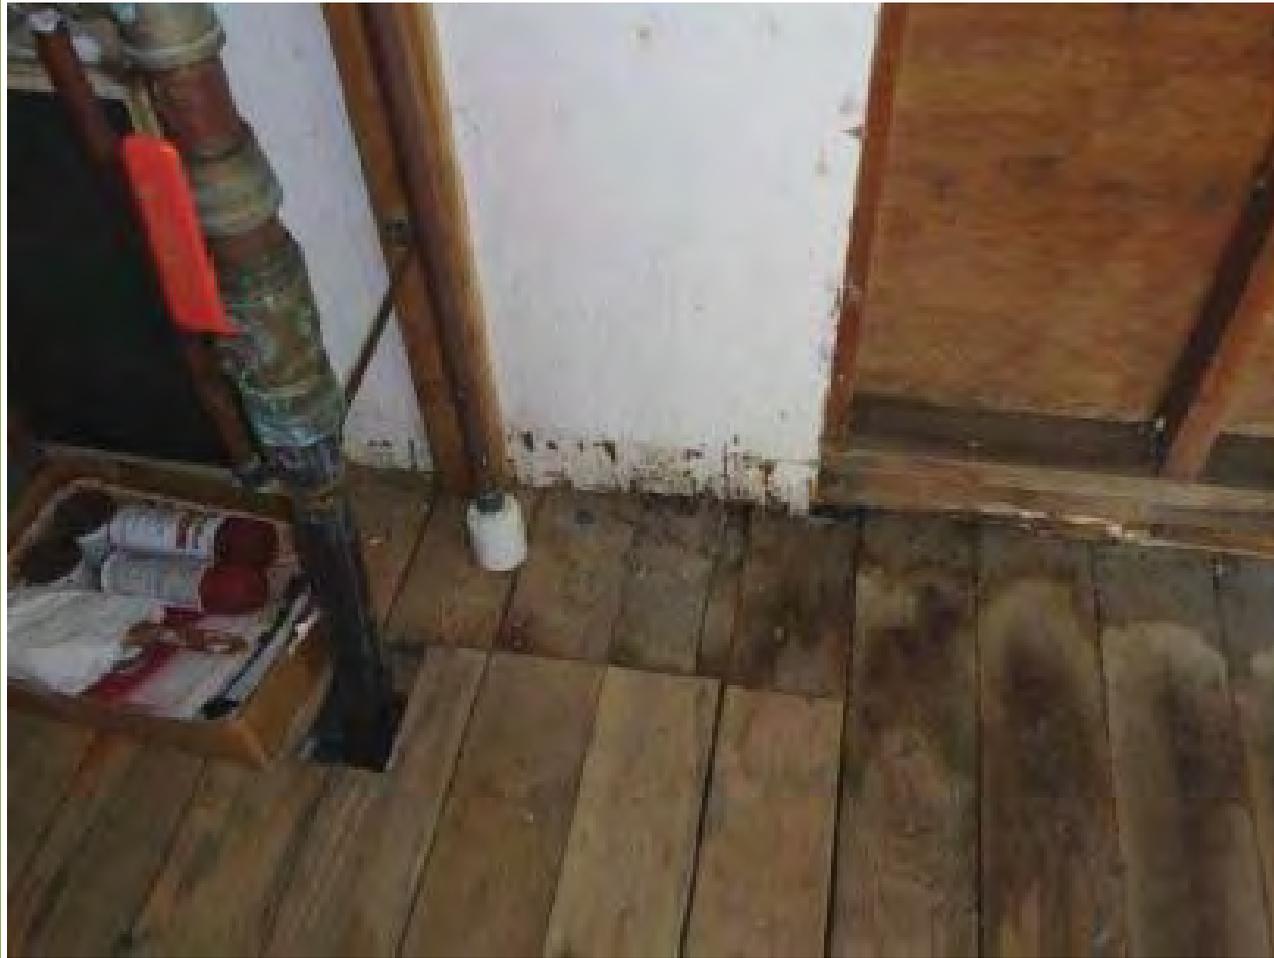
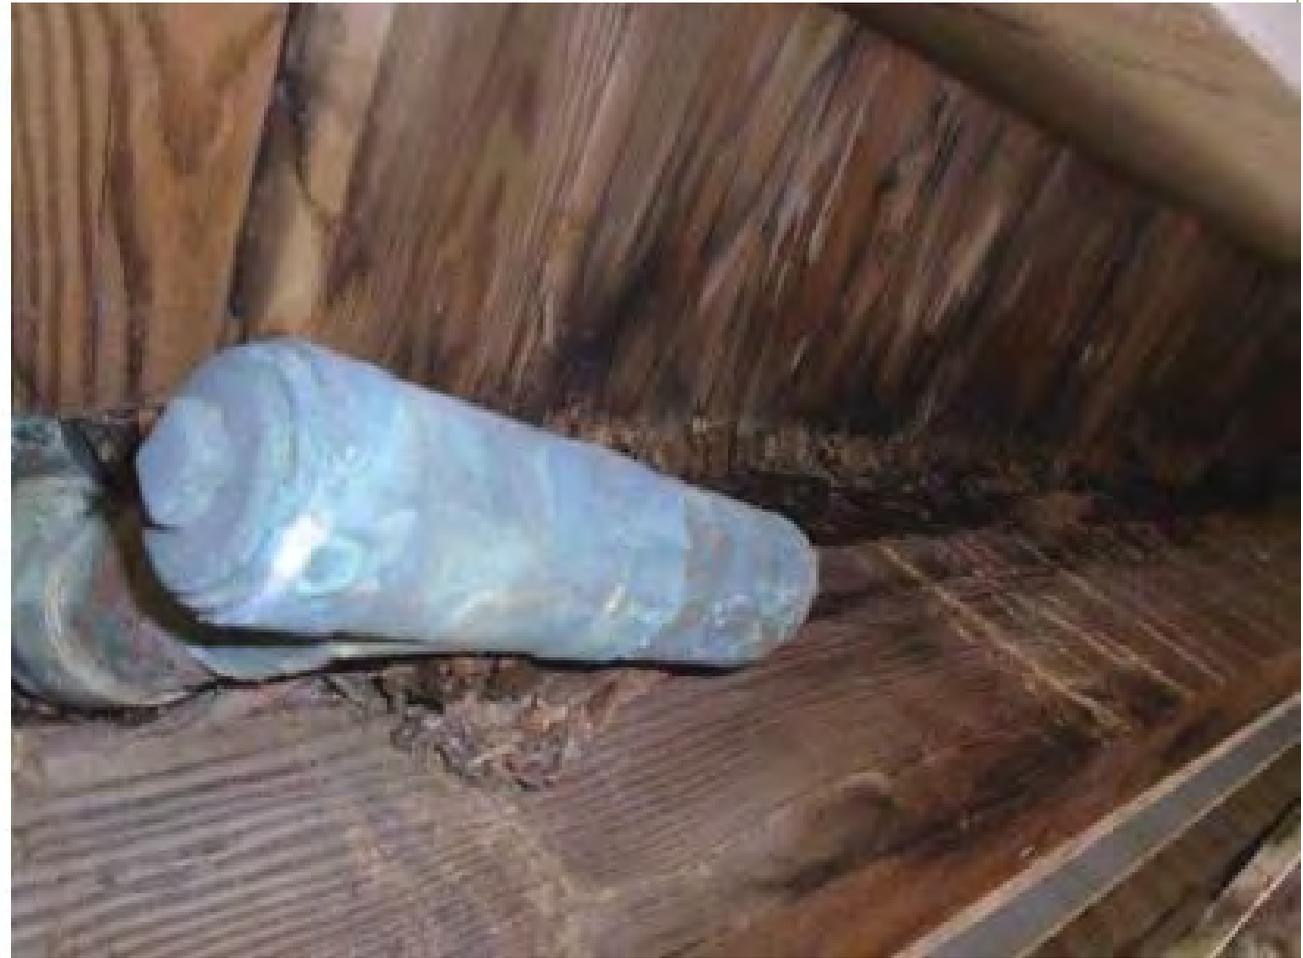
Main Deck Structure - cont.

▶ Exterior Decking and Handrail

Decking on open air portion was replaced with synthetic decking during 2009 renovation. Existing synthetic decking has wave on the surface due to inadequate support. Existing stringer spacing was not amended when synthetic decking was installed and is not adequate.

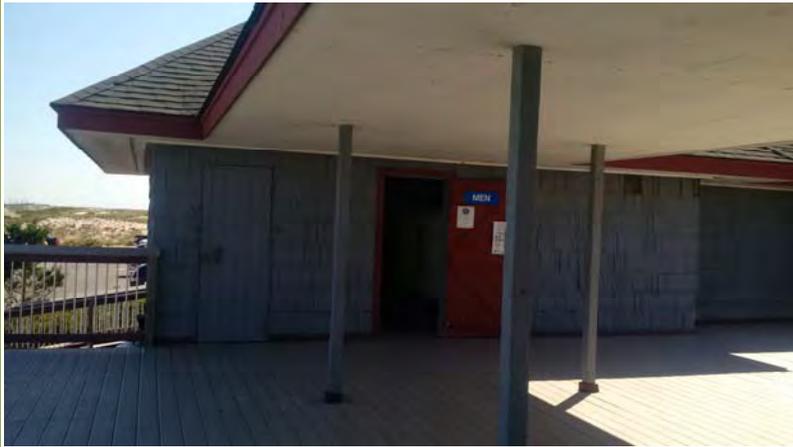
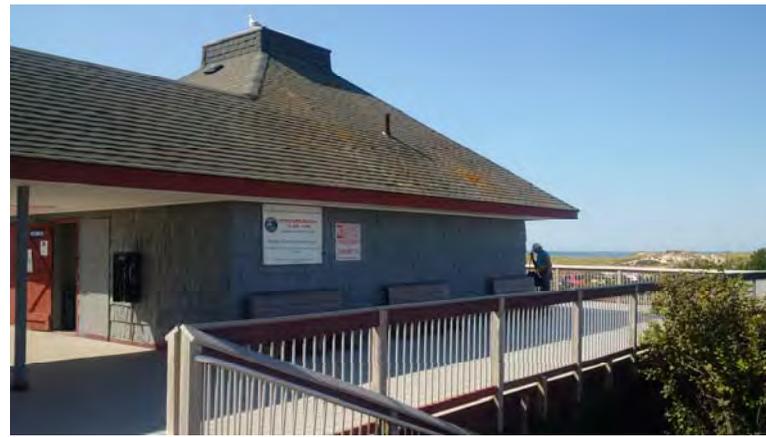
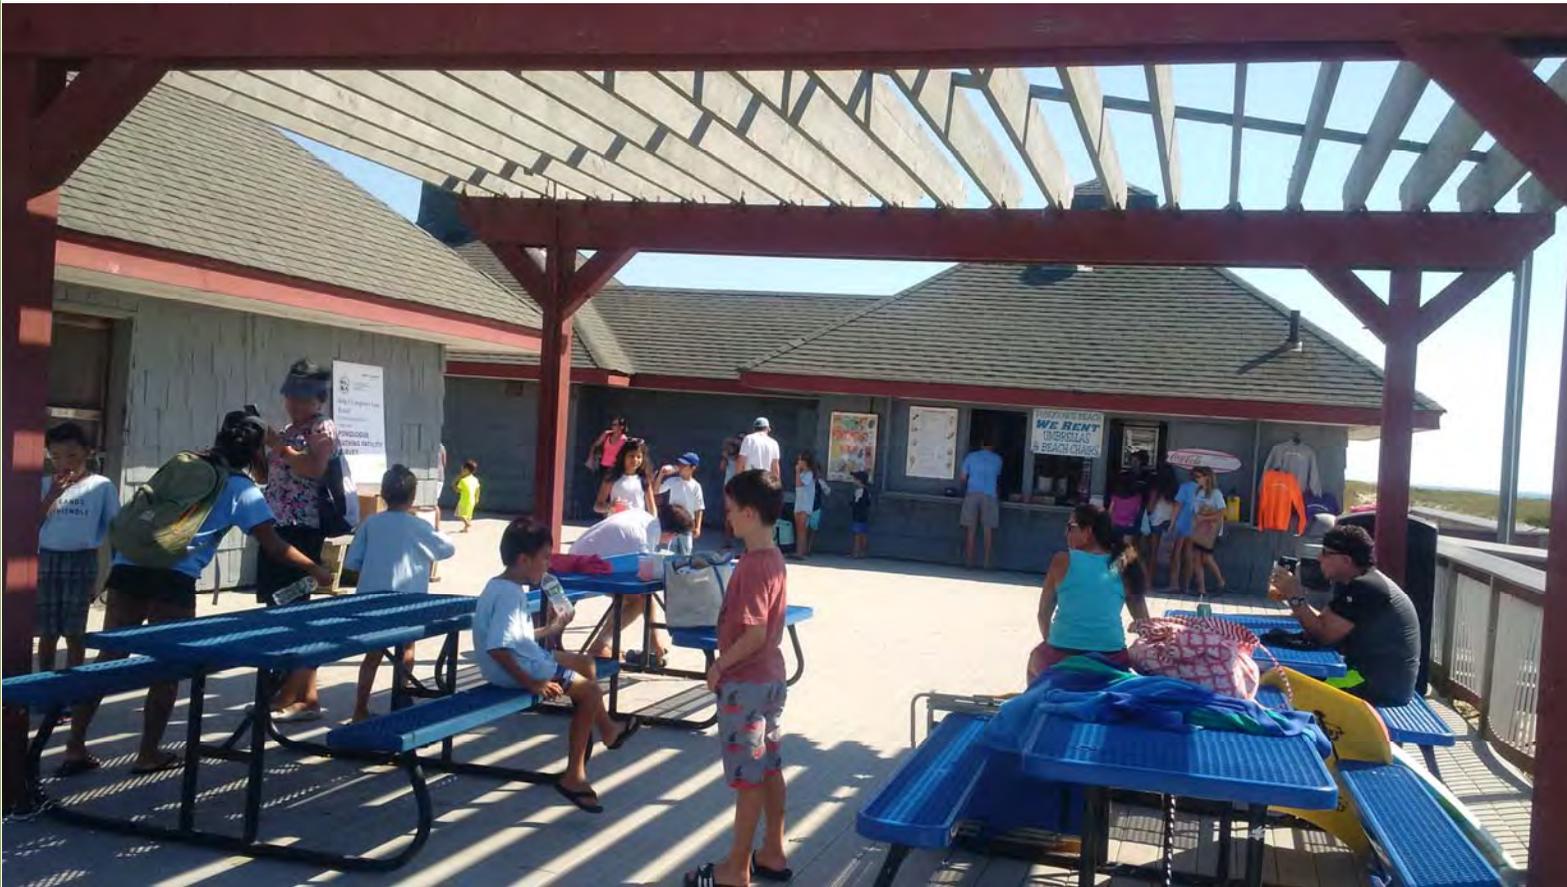
Main Deck Structure - cont.

► Interior Decking

Decking on interior portion – was not replaced in 2009 and remains as wood decking. Rot present in some areas.

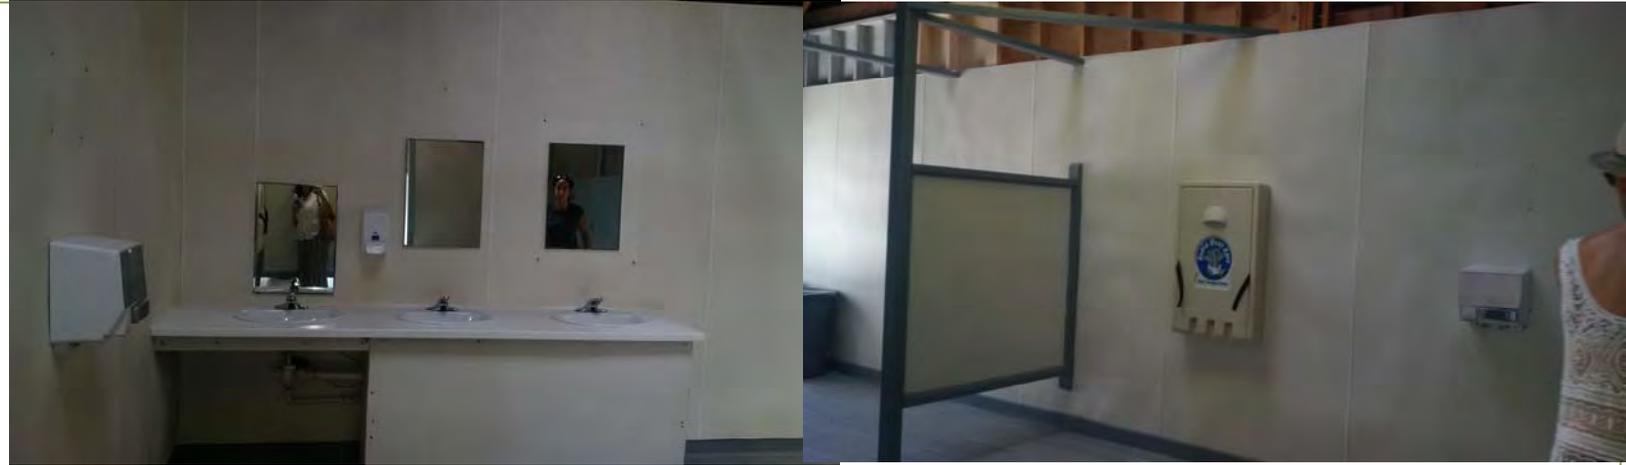
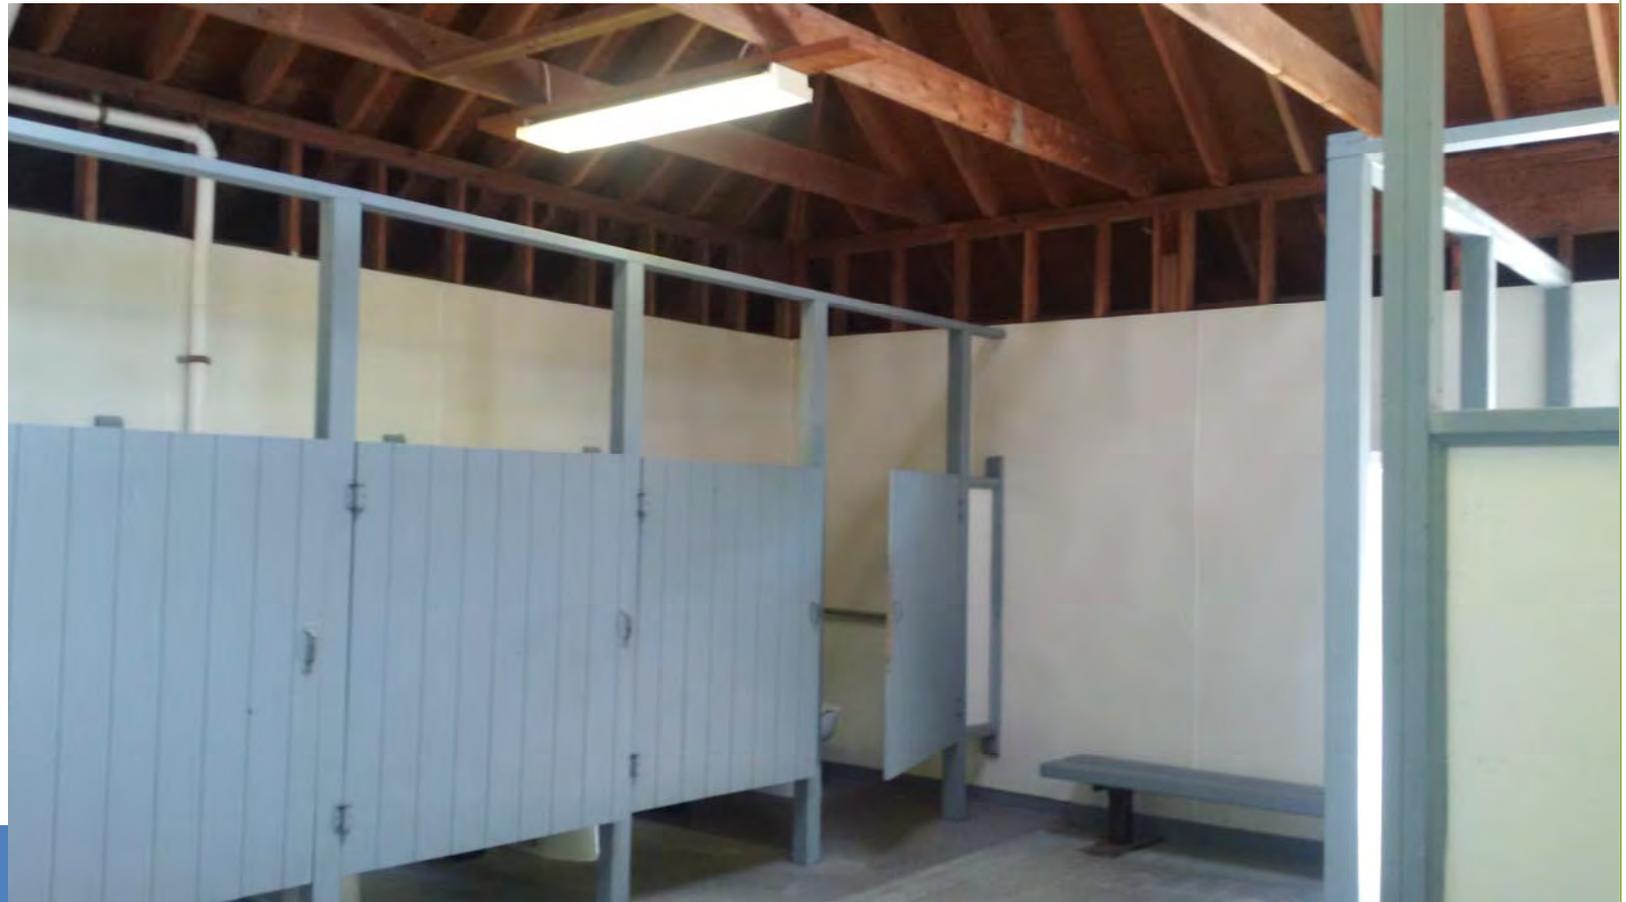
Existing Plumbing Facility

- ▶ N-W Building -
Women's bathrooms,
6 toilets
3 sinks

Lifeguards station,
1 toilet
1 sink

- ▶ N-E bathroom - Men's Bathrooms,
4 toilet
4 urinals
2 sinks

- ▶ S-E building - Concession area has
hooded ventilation

- ▶ Outdoor rinse-off showers on
boardwalk
